LAPPEENRANTA-LAHTI UNIVERSITY OF TECHNOLOGY LUT

Master's Thesis

**A STUDY ON THE FIELD FAILURES OF CERTAIN DIODE
BRIDGE RECTIFIERS**

A power supply manufacturer had experienced field failures of three-phase diode bridge rectifier modules. The modules seemed to lose their ability to withstand voltage. In this thesis, the rectifier modules used by the power supply manufacturer were studied. The power supply manufacturer delivered a total of 35 unused rectifier modules and 50 used field returns. The modules were of three different case types. The objectives of the study were to detect any differences in breakdown voltages or in structure between the case types and to identify possible failure mechanisms of the breakdown.

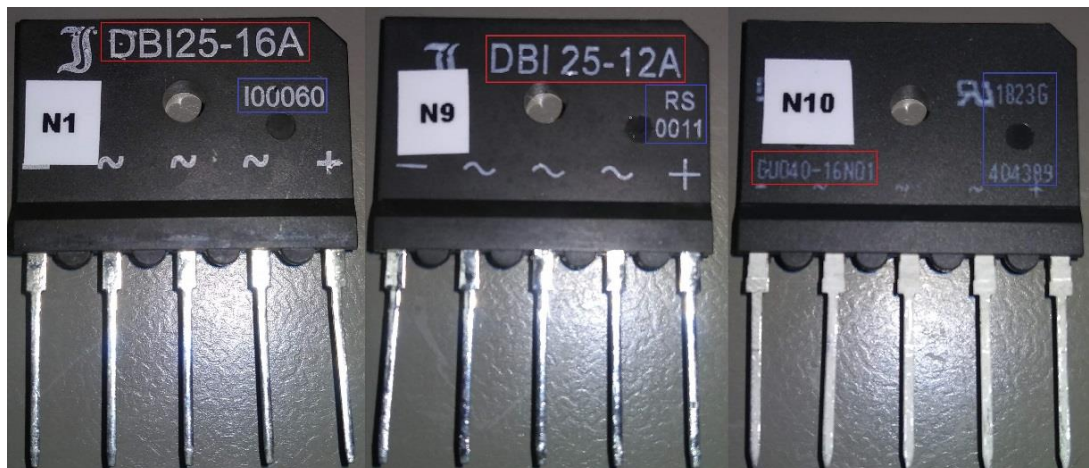
The modules in the research consisted of three different case types that are presented in Figure 2.1. The case types were classified according to the way they were labeled and how the prints were placed on the cases. From Diotec there were two case types (case type 1 and case type 2) and from Ixys there was one case type (case type 3). On case type 1 the model number was on the top of the side of the case and the batch number was on the right half printed in one row. On case type 2 the model number was also on the top of the side of the case, but the batch number on the right half was printed in two rows. On case type 3 the model number was on the bottom left corner of the side of the case and the batch number was on the right half printed in two rows.

Figure 2.1. Three case types with different labeling layouts were recognized. Case type 1 is on the left, case type 2 in the middle and case type 3 on the right. Model names are marked with red and batch numbers with blue.

The used modules of the first batch had already been named and marked by the power device manufacturer. The same method of naming was used for the rest of the modules as well. The modules were named depending on whether they were new unused modules or used modules from returned devices. The new unused modules were named "N" plus a running number and the used field returns were named "R" plus a running number (Table 2.2). The names of the modules were marked to each module using tape (Figure 2.1).

The basic structure was the same for all three case types with six diodes in two rows and with narrow conducting rails connecting the diodes from above and bigger conducting plates connecting the diodes from below as shown in Figure 2.1. However, the conducting parts were shaped slightly differently and there were differences in how the

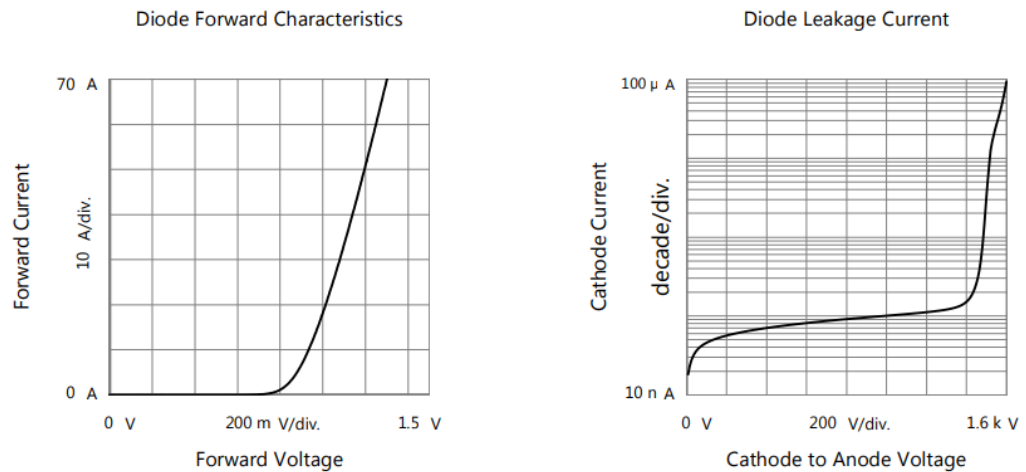
Figure 4.1. Electrical measurements of a diode in rectifier module R17. The measurements were done with the Keysight B1505A Power Device Analyzer / Curve Tracer. On the left is the diode forward characteristics graph and on the right is the diode leakage current graph. According to the datasheet the leakage current was supposed to be less than $5 \mu\text{A}$ at the repetitive peak reverse voltage 1600 V (Keysight Technologies, 2019).

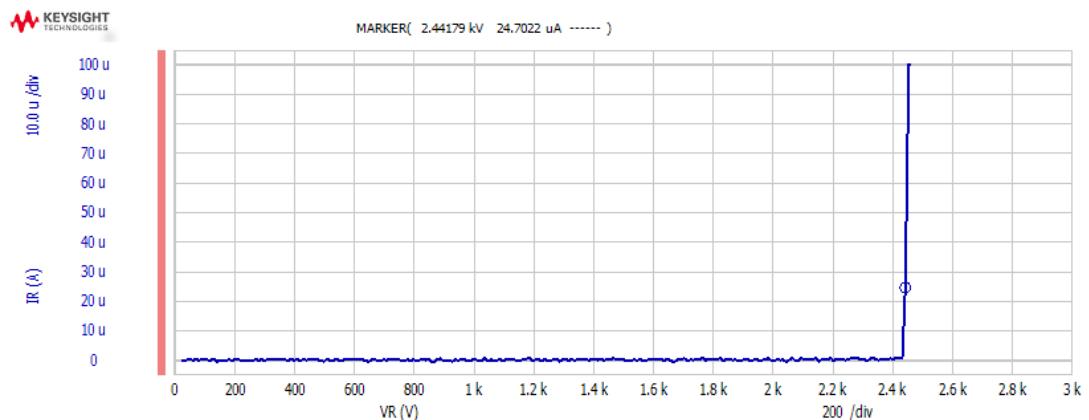
Figure 5.1. Diode working as expected. Breakdown and rapid rise of the reverse current happens at 2440 V.

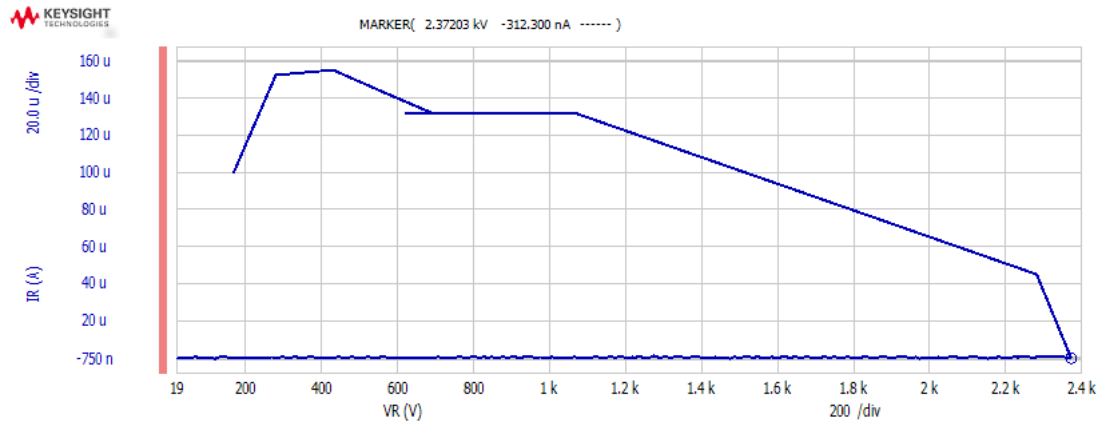
Some diodes got permanently damaged in the measurements and the breakdown voltage dropped to less than one tenth of the previous result. In Figures 5.2 and 5.3 you can see this type of irreversible breakthrough and big decrease of breakdown voltage. Only diodes in case type 1 and 2 modules experienced this type of big decrease of breakdown voltage. 33 % of case type 1 and 11 % of case type 2 modules had at least one diode that

got severely damaged and experienced a big decrease of the breakdown voltage value. This happened in both new and used modules.

Figure 5.2. Irreversible breakthrough happened during measurements. The diode was first able to withstand a reverse voltage of 2370 V, but when the breakdown happened the voltage started to drop.

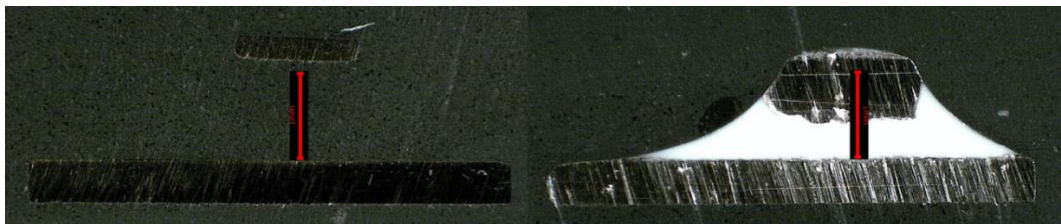
Figure 6.6. The insulation gap was significantly bigger on case type 3 compared to case type 1 and 2. Case type 3 also had the same epoxy as on the case between the live parts whereas case types 1 and 2 had a white dielectric between the live parts. On left case type 3 and on the right case type 2 insulation thickness between live parts.
