**COMPARISON OF STEEL MATERIALS TO REPLACE THE CURRENT
TROLLEY RAIL OF HIGH DUTY CLASS CRANES**

Lappeenranta 18.3.2020

Master's thesis

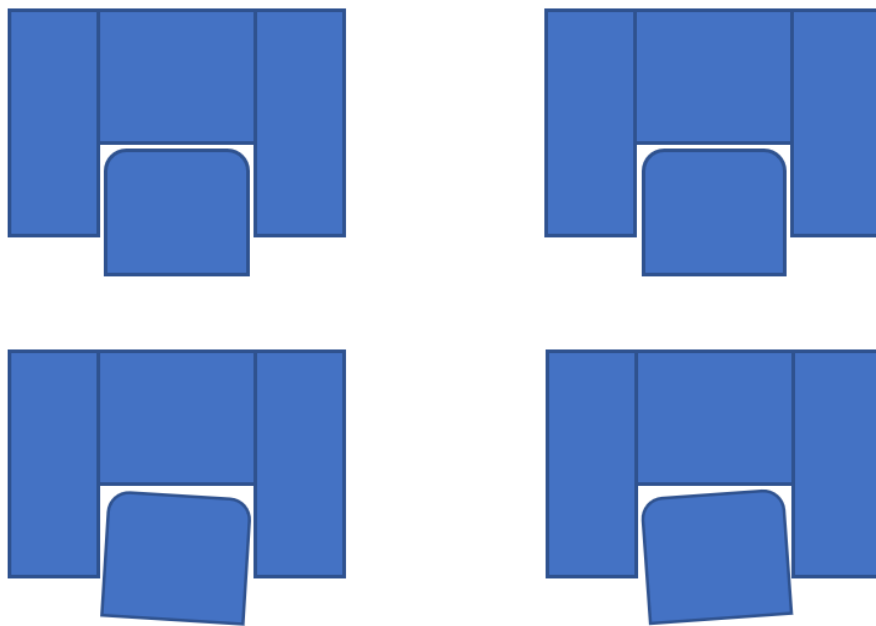
Figure 10 Twisted rail

The top half of Figure 10 shows the ideal position of the rail and the wheel, where the rail is nicely horizontal and aligned with the wheel. The bottom half shows a situation where the crane may end up if the bridge bends under the load, of course the wheels may follow the bend, but not necessarily with the same ratio. This kind of misalignment can cause huge stresses on the wheel and the rail as the surface area will decrease and it can also cause the side of the flange to hit the side of the rail.

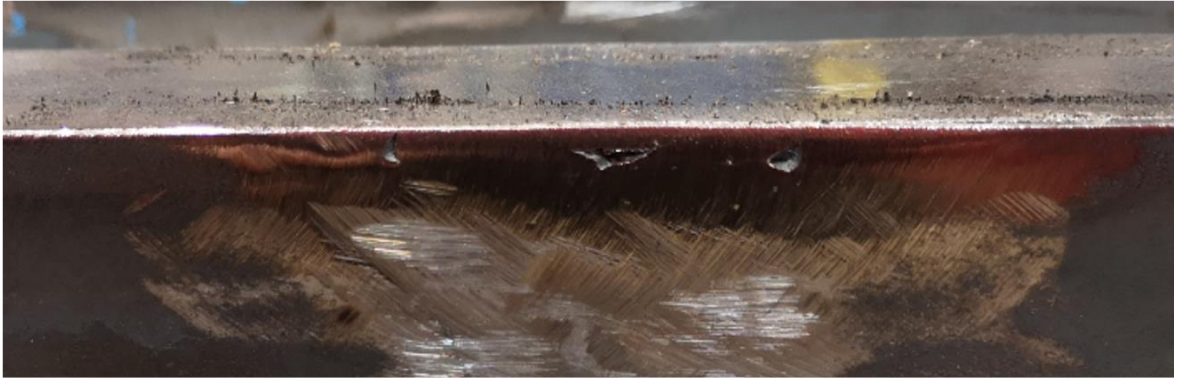
Figure 11 Rail after grinding

After the rail pieces have been welded together the surface is ground until it is smooth and flat. Sometimes the welding is not perfect and small gaps are left under the weld or sometimes they are found on the side the rail and visible to the naked eye as shown in Figure 11. These small gaps cause stress concentrations and can increase crack propagation. Sometimes the surface has been ground too much and the surface is left uneven, which then means that the trolley will have to drive uphill in this position, this increases the likelihood of wheel slip.

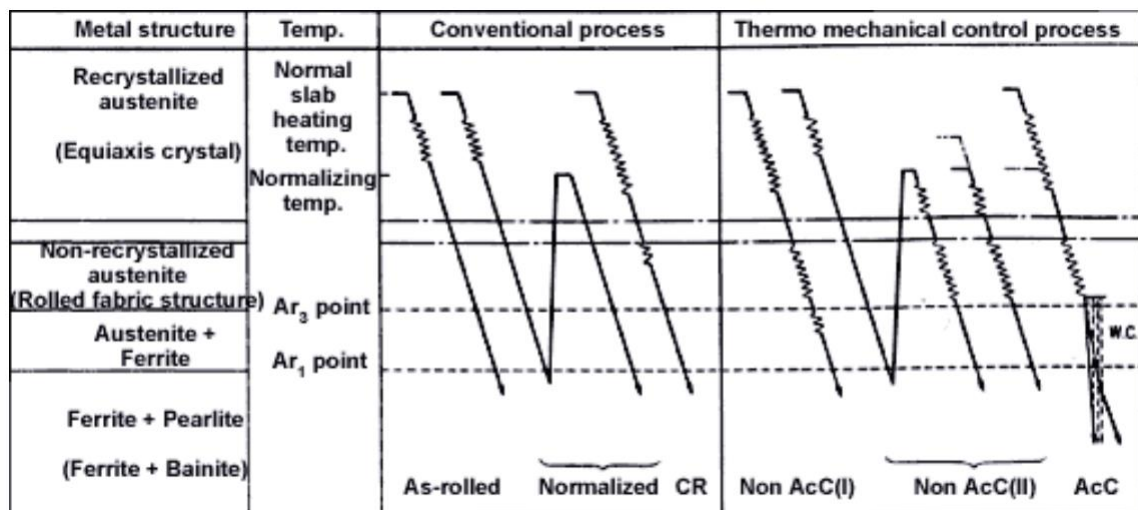
Figure 13 Thermo-mechanical controlled process

Thermo-mechanical controlled process can be done in several ways, three different ways are shown in the right-hand side of Figure 13, the left- hand side shows three similar ways of

rolling, but only conventionally rolled. By rolling with varying temperatures the final microstructure of the steel can be manipulated. All TMCP steels are not necessarily bainitic and martensitic, they can also be ferritic and bainitic. The benefit of TMCP steels is a lesser need for alloying elements, which results in a lower CEV value and a better weldability. (Pirinen, 2013, p. 16) (TWI, 2019)

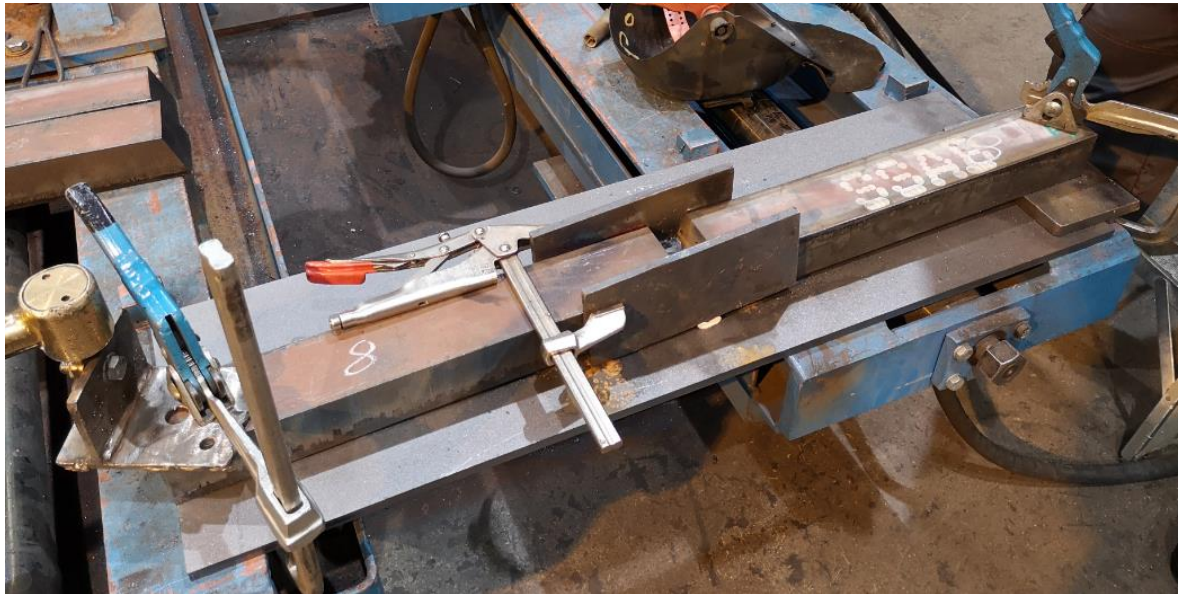
Figure 19 Welding setup

Figure 19 shows the setup before welding was started, both ends are clamped to minimize angular distortions and two copper plates are used on both sides of the weld to help with smoother sides and minimize grinding need after the welding, also a ceramic backing is used under the weld.

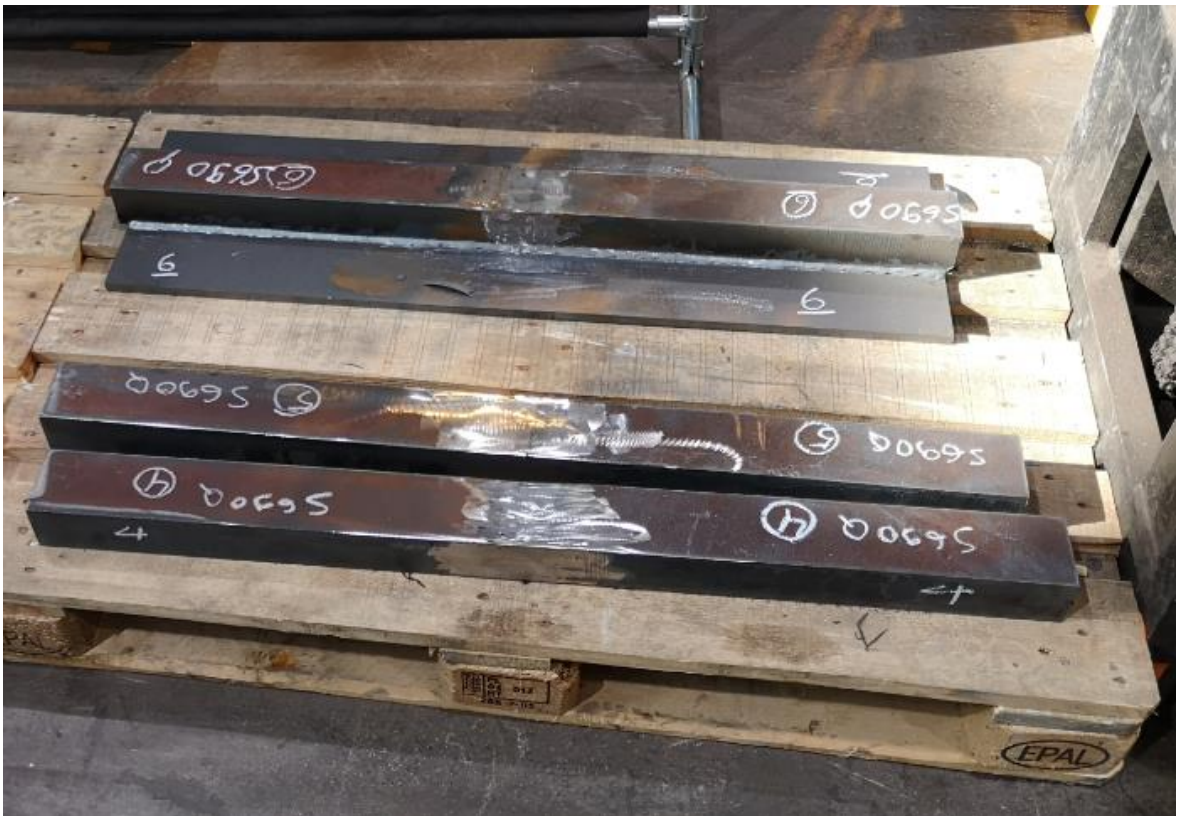
Figure 21 Finished test pieces

Figure 21 shows a finished set of S690Q test materials, all test pieces were labelled with a sequential number and material type to keep track which test piece is which. From figure 21 we can also see the fillet weld for the test piece 6. Similar fillet weld into a plate of S355 was done for test pieces 3, 9 and 12.
