LUT UNIVERSITY
LUT School of Energy Systems
LUT Mechanical Engineering

**REPAIR WELDING OF HIGH ALLOYED AUSTENITIC CAST STAINLESS
STEEL**

Master's thesis

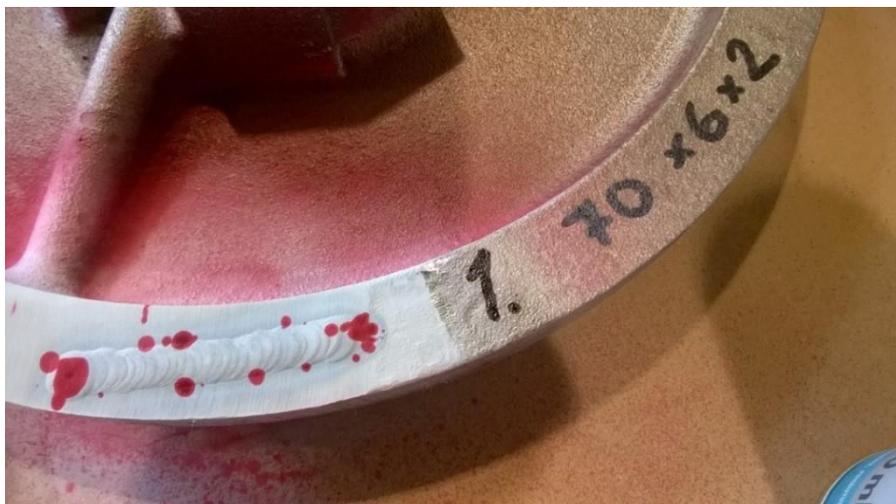
Figure 1. Weld in the first test piece. (Hurri, Sulzer Pumps Finland Oy)

Previous tests done with AS1 parts showed that porosity and other imperfections found in castings are difficult to repair by welding as the repair welds have also tendency to crack easily. Thesis focuses on sorting out the reasons behind the hot cracking when welding austenitic stainless steels, by examining material properties and effect of impurities to welding. High silicon content increases the corrosion resistance abilities against strong sulfuric acids when compared to more traditional austenitic stainless steels. This change is thought to affect negatively to the welding abilities of the material studied.

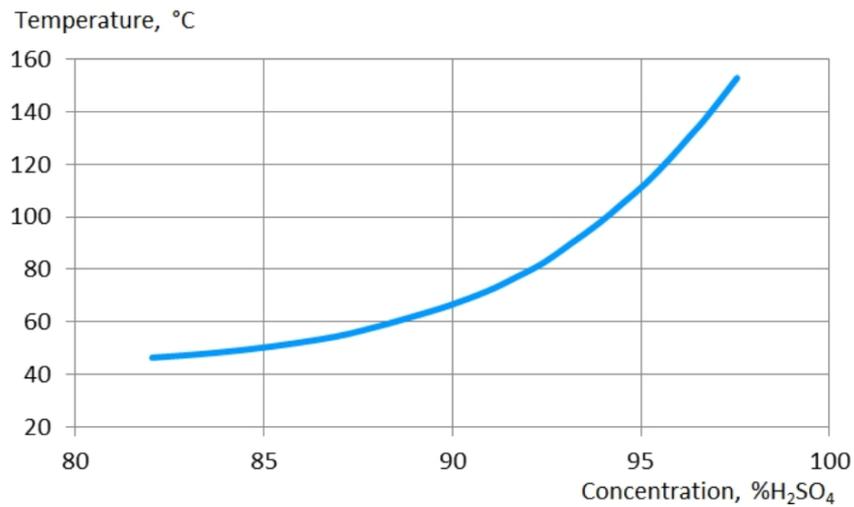
Figure 2. Corrosion diagram for Sandvik SX against H₂SO₄ in static conditions. (Sandvik SX datasheet)

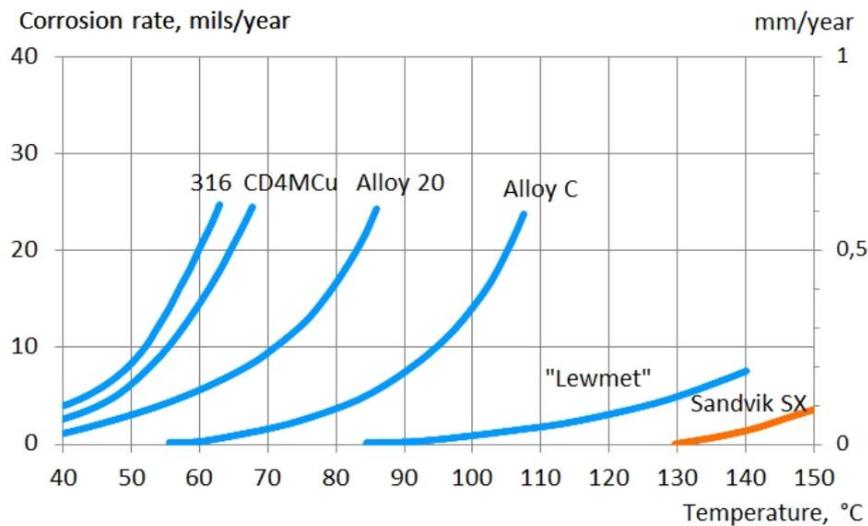
Figure 3. Approximated corrosion rates of different alloys in 98% H₂SO₄ at static conditions. (Sandvik SX datasheet)

It has been demonstrated that a 3.5 % silicon composition improves the corrosion resistance of stainless steel in hot, concentrated nitric acid in the presence of oxidizing species (Laurent, 2017, p.1). High silicon composition ensures good corrosion resistance abilities also in high concentrated sulfuric acids. Sandvik SX's corrosion resistance abilities against H₂SO₄ acid is presented in Figure 2. This isocorrosion diagram pictures the corrosion rate of 0.1 mm in a year as a line for Sandvik SX. In circumstances above the line corrosion rate is higher, and below the line lower, than 0.1 mm in a year. It is noticeable that the composition used has actually better abilities against corrosion at least in sub 160 °C liquid temperatures when the acid concentration is increased. This ability is compared with the abilities of other alloys in same conditions at Figure 3.

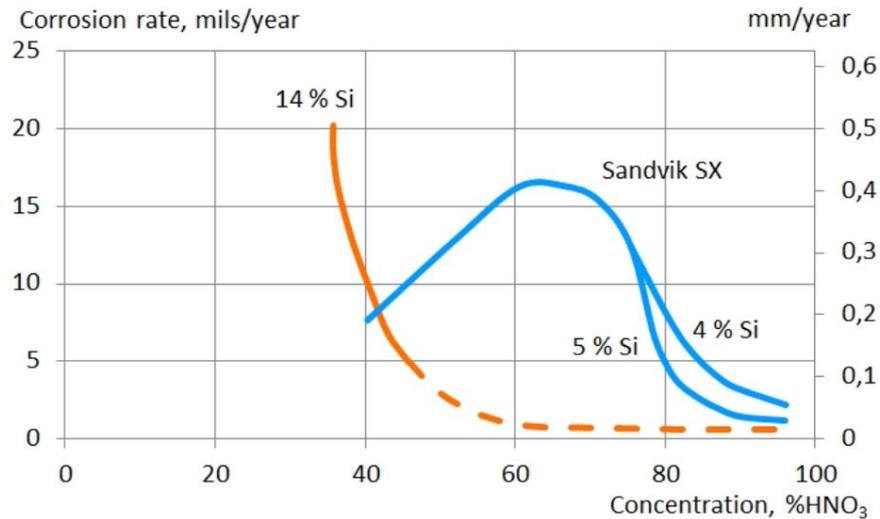
Figure 4. Effect of silicon content to corrosion resistance in HNO₃. (Sandvik SX datasheet)

The positive effect of high silicon content in steel compositions used at surroundings containing strong nitric acids (HNO₃) can be seen in Figure 4. Sandvik SX has excellent corrosion resistance abilities when process includes strong acids. Corrosion rates of steels that have 14 % of silicon alloy in their composition can be matched with Sandvik SX in such surroundings including strong acids. Sandvik SX has much lower 5 % silicon composition. Lower amount of silicon allows material to have other better abilities such as weldability for example. Sandvik SX should be welded with as low heat input as possible (max 1.0 kJ/mm). The interpass temperature shall be kept below 60 °C. Sandvik states that the welding

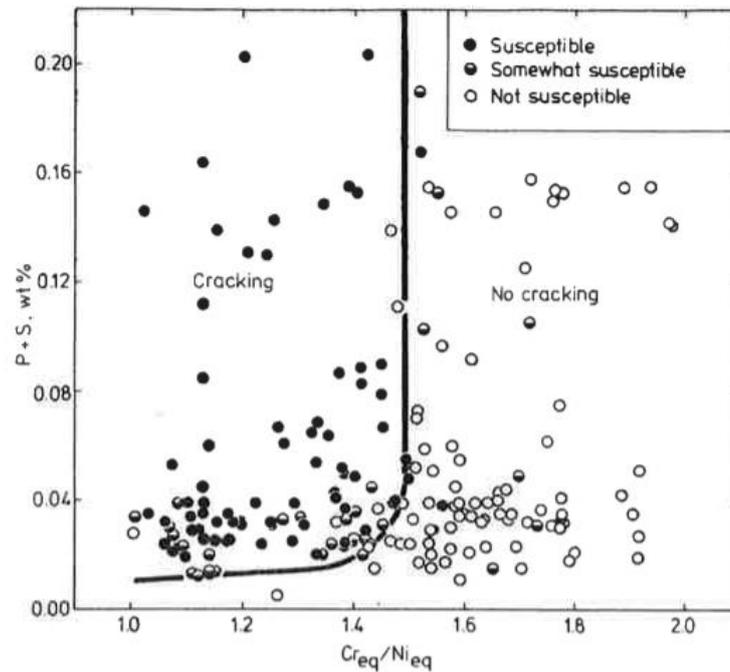
Figure 5. Results of hot cracking tests plotted on field of $Cr_{eq}/Ni_{eq} - (P + S)$. (Kujanpää et al.)

Susceptibility to solidification cracking on point of austenitic stainless steels has been studied for example by Finnish researchers Kujanpää and Suutala with their team. They made a series of test welds with AISI/AWS 300 series steels, see Figure 5. Results of these test were discussed in studies published from the topic. Team concluded that solidification cracking is highly dependent on the solidification mode, which is affected essentially by the chemistry of the weld metal more specifically its chrome equivalent (Cr_{eq}) and nickel equivalent (Ni_{eq}). Duplex ferritic-austenitic solidification in welds with median values of 1.5 - 2.0 Cr_{eq}/Ni_{eq} ratio produce the minimum cracking susceptibility. As a comparison austenitic solidification welds, Cr_{eq}/Ni_{eq} ratio below 1.4, commonly are very susceptible for cracking. Material's solidification cracking susceptibility can be estimated prior welding if exact

material composition is known. This tendency for cracking can be estimated with the mentioned value of Cr_{eq}/Ni_{eq} and with sum of impurities, phosphor and sulfur (P + S). (Kujanpää et al., 1980) Cr_{eq} and Ni_{eq} values can be calculated with Equation 1 and 2.

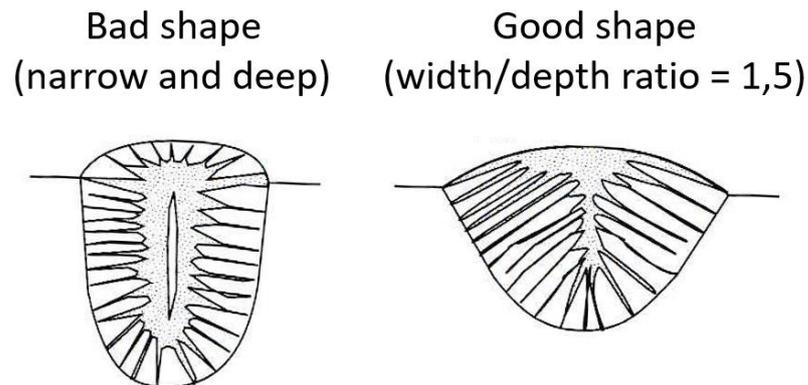
Figure 6. Illustration of weld cross sections in terms of preventing hot cracking. (Kyröläinen)

ratio will be found between these values presented. In repair welding, correct shape of weld is ensured by grinding the surrounding of the crack so that width to depth ratio of the grinded area is within the values mentioned. Weld which depth is larger than its width eases the cracking by guiding and concentrating the impurities to the middle of the weld, see Figure 6.

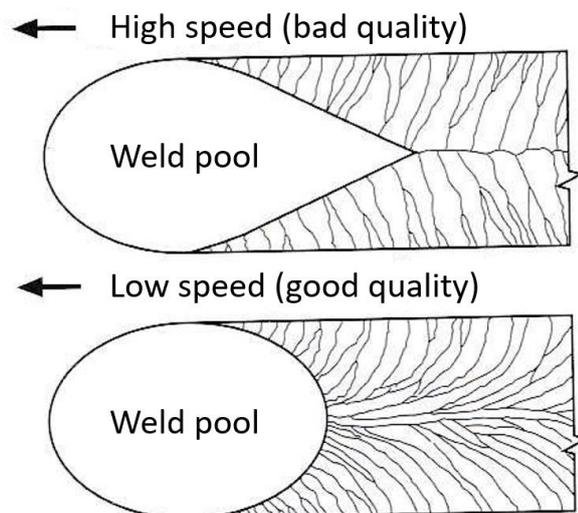
Figure 7. The effect of welding speed on concentration of impurities to the centerline of weld. (Kyröläinen)

Lowering travel speed of welding also helps as the weld pool won't form out as tear drop. Tear drop shaped pool eases the movement of impurities towards the centerline of weld simultaneously easing the crack formation as molten material solidifies vertically against the fusion line of molten and solid material. If welding speed is high and molten material forms out as a tear drop, possibility for situation in which solidified grains from both sides of weld grow to the middle of the weld and merge exists. In that situation impurities at weld centerline may form out as a hot crack, see Figure 7. (Kyröläinen, 2002, p.62) This effect is similar to concentration of impurities caused by narrow and deep weld.

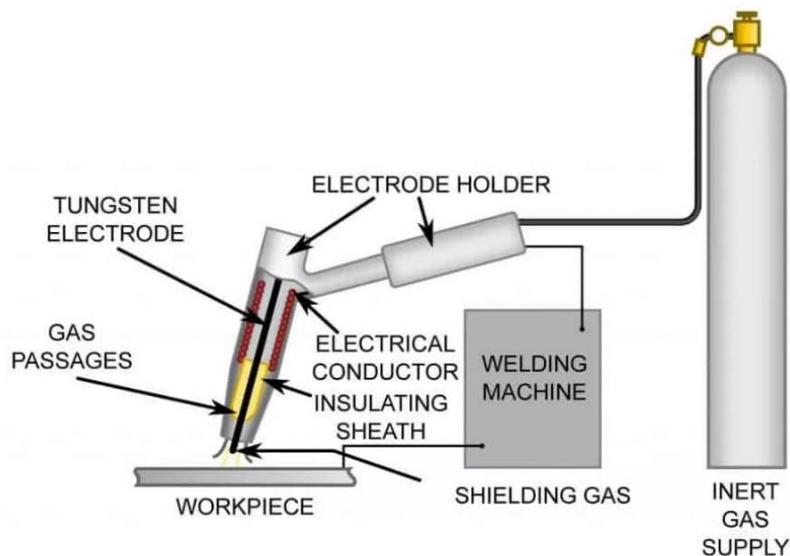
Figure 8. Working principle of TIG welding machinery. (www.weldingpros.net)

In TIG welding the arc is formed between a pointed tungsten electrode and the workpiece in an atmosphere of argon (Ar), helium (He) or mixture of both. In DC welding, normally applied when welding steels, electrode usually has negative polarity and the work piece has positive polarity. Positive effects of negative electrode polarity are strong arc concentration, deep weld penetration and small electrode consumption. Changing the polarities also change these effects vice versa. Electrode is not consumed during welding so additional metal needed in filling the joints must be added separately in a form of wire. (Lucas, 1990, p. 9) Working principle diagram in Figure 8 shows the essential machinery; electrode and electrode holder, AC or DC power source and shielding gas supply needed in TIG welding.

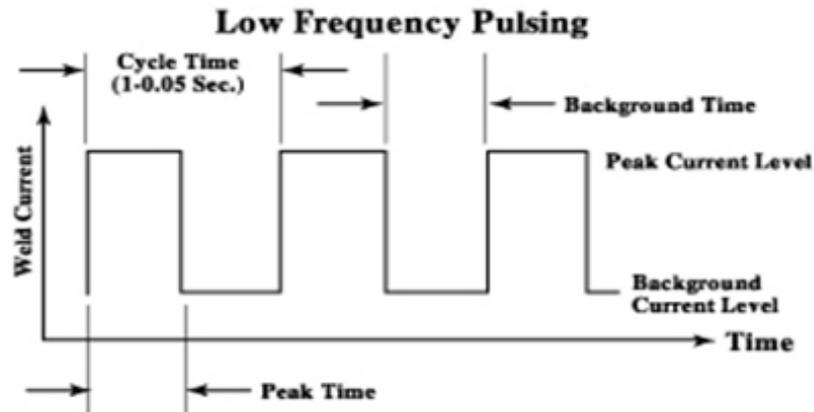
Figure 9. TIG pulse welding (<https://www.adorwelding.com>)

TIG welding can be carried out also by pulsating the electrical current used. In pulse TIG welding current used changes between two values, background current and peak current, see Figure 9. Weld pool and penetration of weld are created during the peak current. Background current allows the weld pool to cool down and solidify. Pulse TIG welding is used to ease the welder's control of weld pool and heat input. (Kyröläinen, 2002, p.352) It can be stated that same weld penetration can be achieved with pulse TIG welding compared to constant current at the same time having significantly lower heat input.

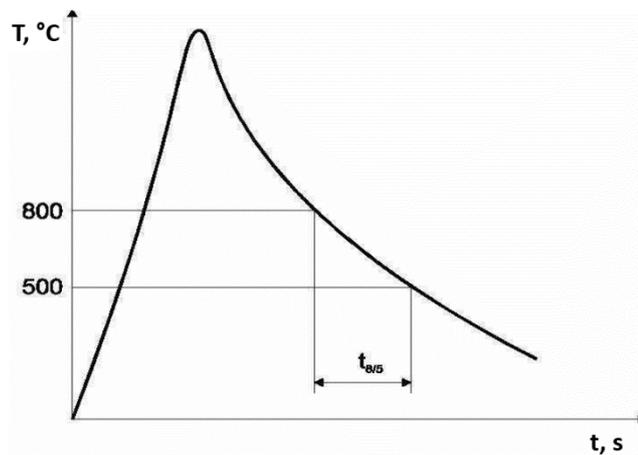
Figure 10. Thermal cycle of welding and the definition of cooling time $t_{8/5}$.
(www.weldnet.com)

Fast and significant temperature changes ease the hot cracking of welds. Most significant changes in the microstructures of low-alloyed steels occur when the weld cools between the range of 800-500 °C, see Figure 10. Because of this cooling time for such materials is described with factor $t_{8/5}$ which indicates the time passing between temperatures previously mentioned. When studying austenitic stainless steels, the cooling time differs greatly between the phenomena's wanted to investigate so $t_{8/5}$ isn't always the best indicator. (Kyröläinen, 2002, p.57) For austenitic stainless steels it is common to measure the cooling time between 1200-800 °C with factor $t_{12/8}$ as this temperature range covers the range in which hot cracking usually forms out in austenitic stainless steels. Naturally smaller the cooling time measured is the smaller are the effects of heat input in produced weld.

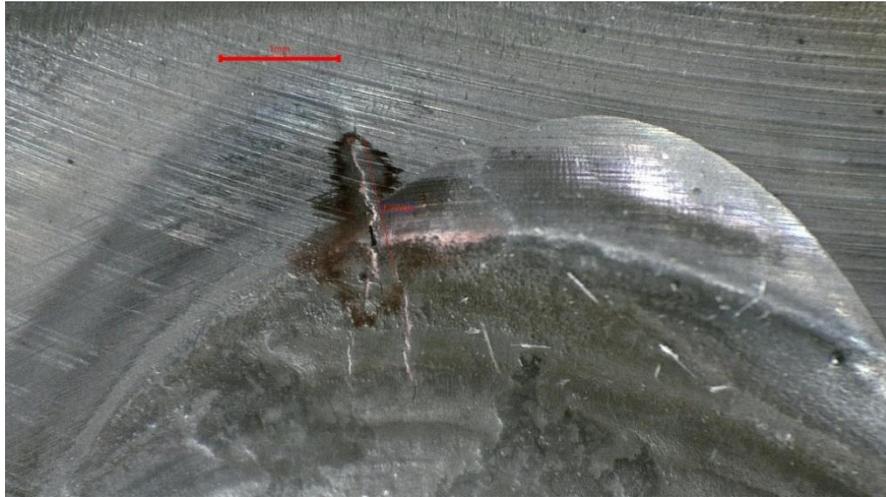
Figure 11. Crack found from the first test specimen welded with original parameters.

Experienced failure is confirmed by manufacturing test pieces from original material samples at SPFIN using parameters set for repair welds previously by Hurri. Sandvik SX filler was used to manufacture welds to openings with width to depth ratio of 6 mm / 2mm. Arc current was set to 140 A and impurities were cleaned off from the test specimen with acetone. Penetrant fluid tests as well as microscopic and macroscopic examinations were carried out at LUT Laboratory of Welding Technology to confirm the failure occurring in produced welds. Figure 11 and Figure 12 show macroscopic images of the cracks found in the test specimens. These figures show that hot cracking failures are occurring in both the weld metal and parent metal.

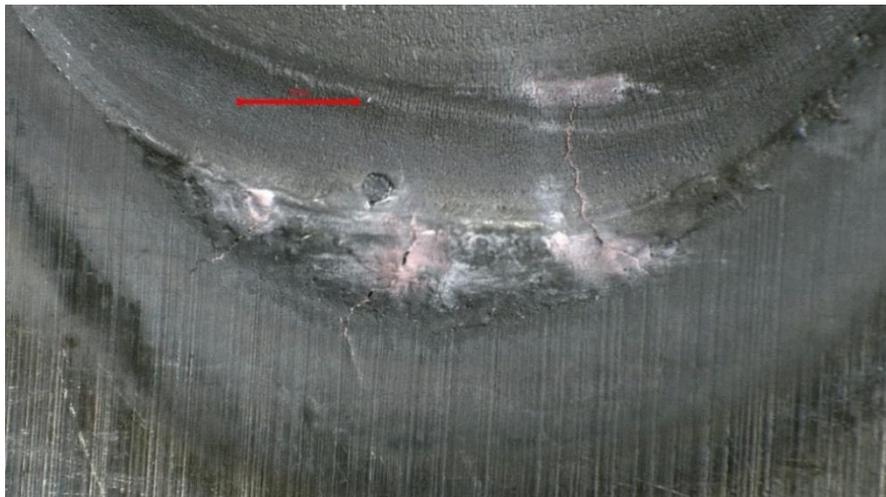
Figure 12. Cracks found at the second test specimen welded with original parameters.

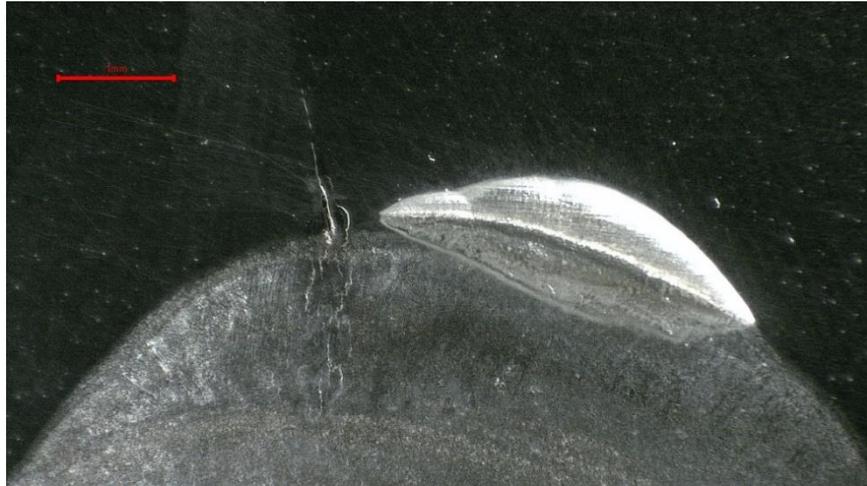
Figure 13. Appearance of crack in first test specimen after machining.

Microsection samples were made by cutting and machining the samples from the test specimens in order to achieve better view of failures in welds. First the top plane of test piece was machined planar to see the formed cracks more clearly, Figure 13 and Figure 14. In both figures the cracks are formed to the starting point of the weld.

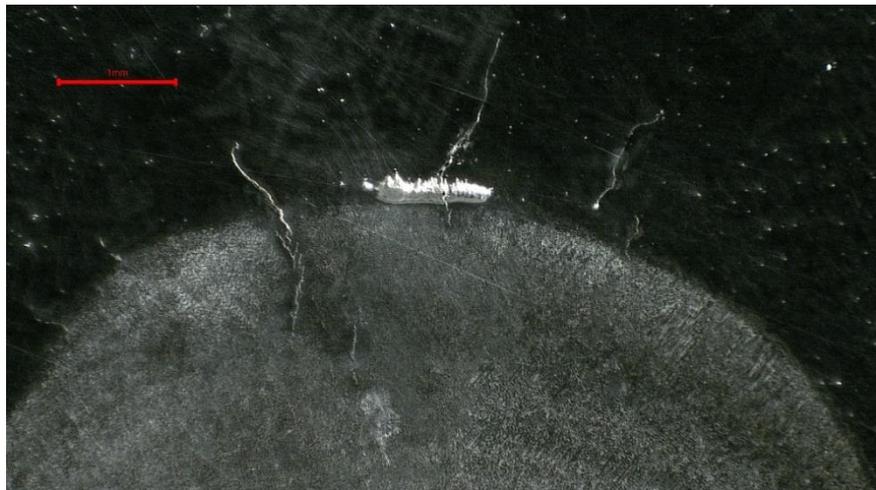
Figure 14. Appearance of crack in second test specimen after machining.

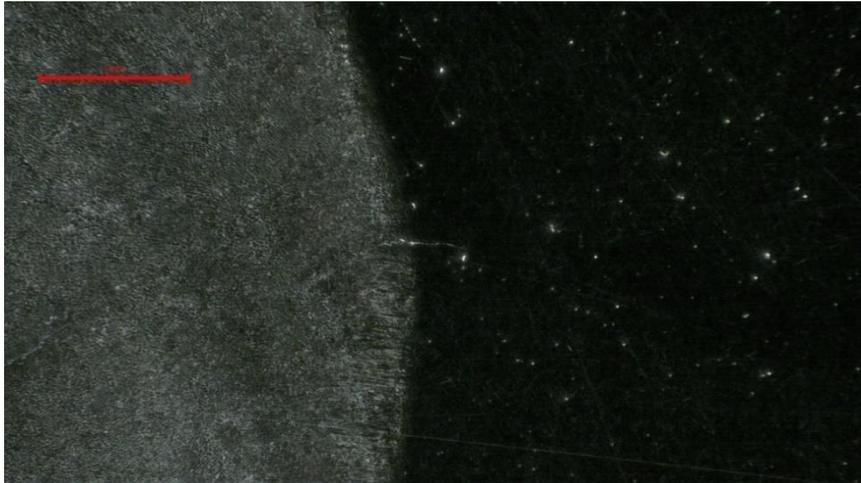
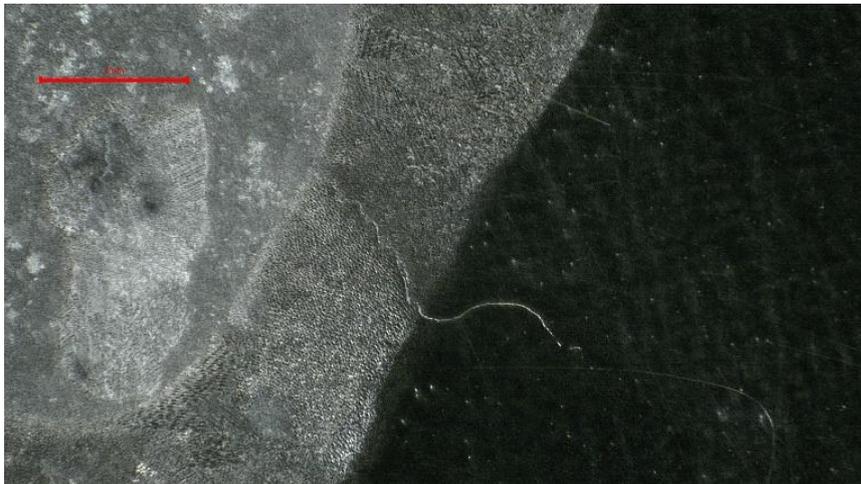
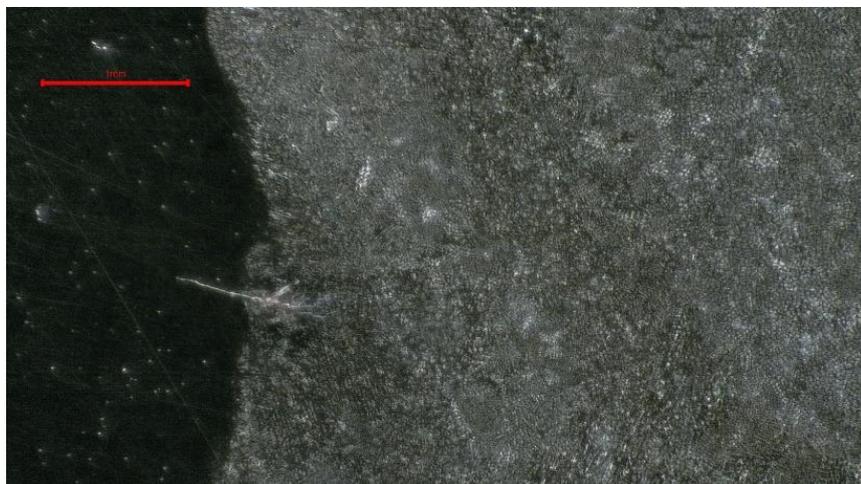
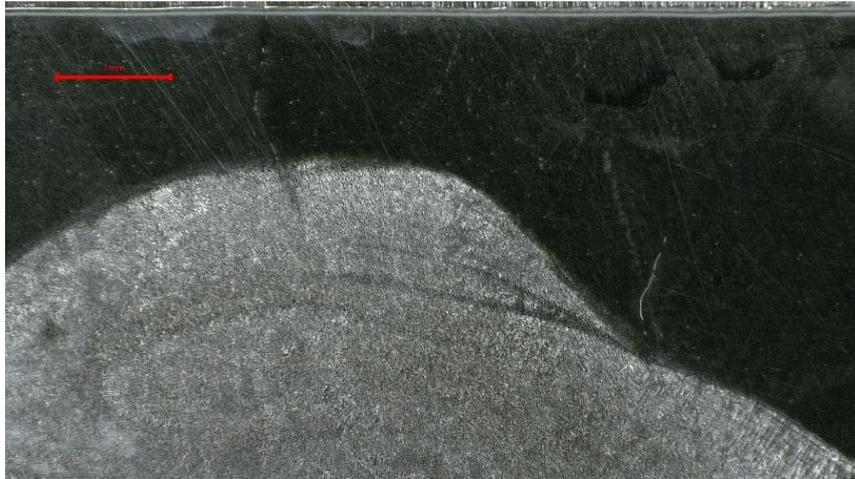
Figure 15. Crack in the weld's beginning on second test specimen.

Figure 16. Crack in the weld's end at the right side of second test specimen.

Figure 17. Crack in the weld's end at the left side of second test specimen.

Figure 18. Cracks in the weld's ending on second test specimen.

More similar cracks at weld starting and ending points can be seen on second test specimen on Figure 15 to Figure 18. As all the cracks have formed to the base material, it can be stated that the used filler metal seems to be suitable for these welds and it can be used for further studies.

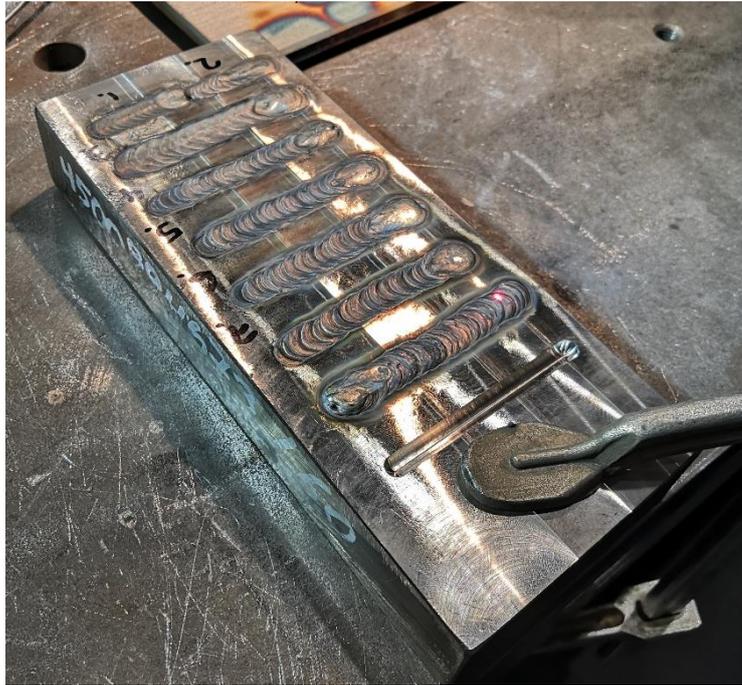
Figure 19. Test welds being welded to the test piece.

Actual test welds were made with small modifications in each test by changing just one parameter between welds, see Table 7. These modifications include tests with different groove geometries and heat inputs affected by the used welding current. Best combinations of parameters in those tests, after visual checking, were used in multipass tests with an interpass temperature of 60 °C along Sandvik's guidelines, Table 8. Welding tests were made to material sample pieces provided by SPFIN which were machined at LUT Laboratory of Welding Technology for wanted groove geometries. Welding was made manually to these test pieces by laboratory staff, Figure 19.

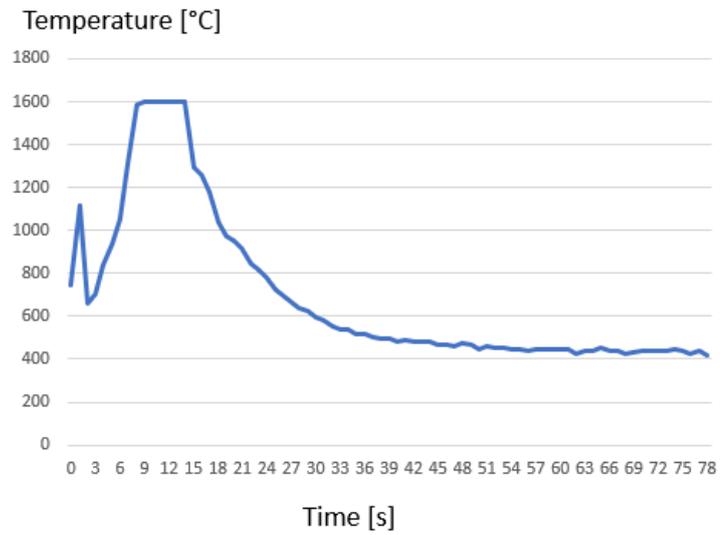
Figure 20. Thermal cycle for welding of AS1.

Temperature change in weld area was monitored in all the tests made at LUT Laboratory of Welding Technology. Changes were measured with pyrometer which can be seen in top left corner of Figure 21. Data collected from temperature changes in tests was used to determine cooling time $t_{12/8}$ for material AS1 studied. Cooling time $t_{12/8}$ was approximately 6 seconds when data from all test welds was put together and analyzed, see Figure 20.

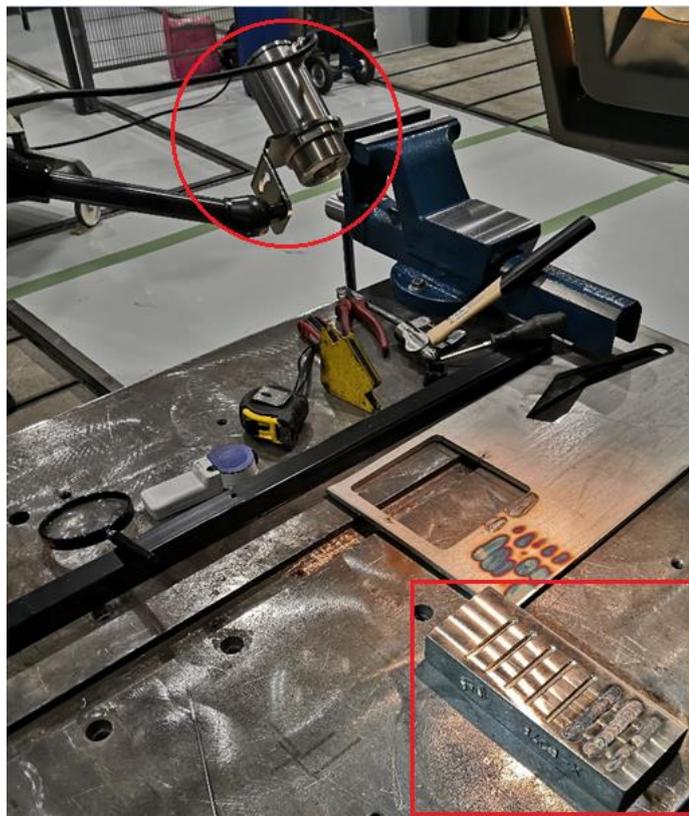
Figure 21. Test setup at LUT Laboratory of Welding Technology. Pyrometer highlighted at the top left corner of picture. Test specimen with machined grooves and already produced test welds can be seen at the bottom right corner.

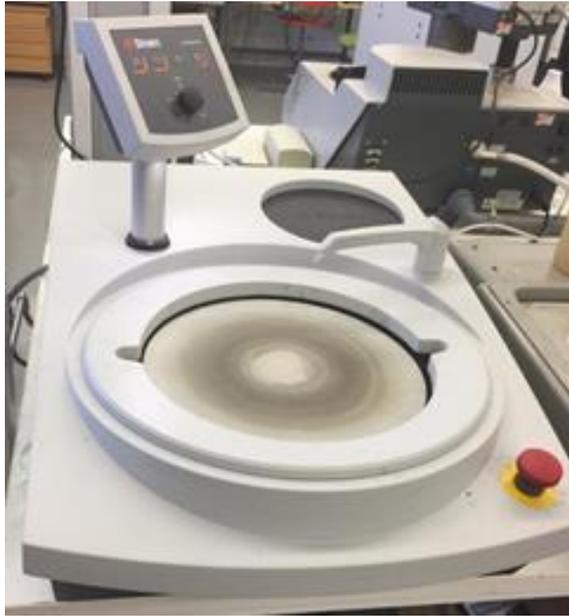
Figure 22. Grinding machine used in preparation of microscopic and macroscopic pieces.

Macrographic pictures were taken from all the test welds. Sample pieces were cut in half to show the weld cross-sections. More cuts were made with a band saw in order to make separate sample pieces from each weld cross-section. These weld cross-sections were then grinded with machine shown in Figure 22. Multiple grinds were made with grinding papers that had different roughness values. After grinding, polishing was made with aluminum oxide. Acid containing 4 % nitric acid was applied after that to the polished surface so that weld base material and weld could be more clearly seen in macroscopic and microscopic examinations.

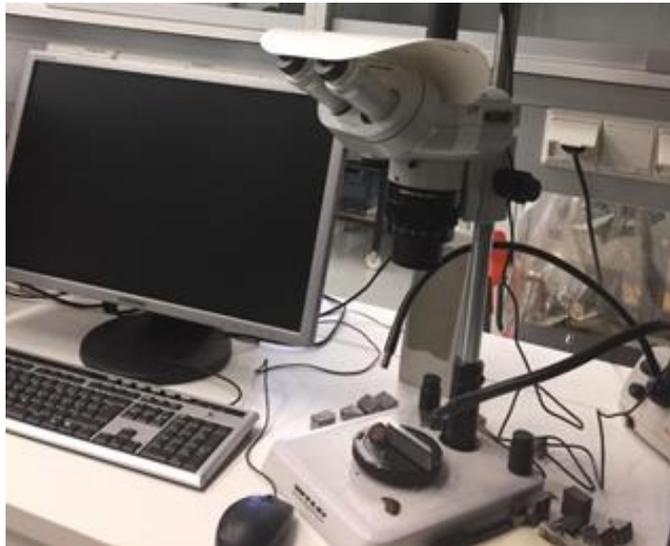
Figure 23. Microscope used for macrographic pictures.

Macrographic pictures were then taken with a microscope shown in Figure 23. Illustrative line of 1 mm was applied to all the macrographic pictures so that the scale of failures would be more easily compared between the samples.

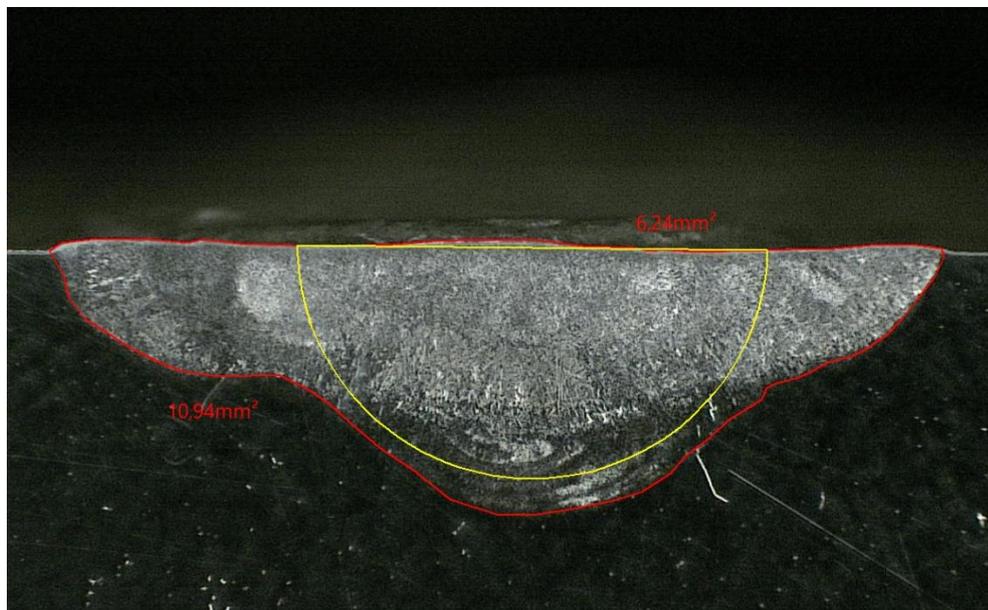
Figure 24. Areas needed to measure when determining base material's mixing ratio. Area highlighted with red shows the cross-sectional area of weld metal and area highlighted with yellow describes the weld groove geometry. Area left between these two areas describes the cross-sectional area of molten base material.

Base material's mixing ratio i.e. dilution ratio was calculated from all test welds made at LUT Laboratory of Welding. Mixing ratio was calculated by determining the cross-section areas of weld geometry and groove geometry. By calculating how much base material is mixed to weld material. Dilution ratio can be calculated by reducing cross-sectional area of weld groove from cross-sectional area of weld metal. This cross-sectional area of melted base material is divided by weld materials cross-section. If the weld forms out as a convex, dome left above upper plane of base material needs to be added for groove cross-sectional area. Examinations were done by using ToupView3.7 software to draw the areas to existing pictures from welds, see Figure 24. Calculations with the values picked from the pictures were then made by using Microsoft Excel 365. For example, in Figure 24 area of weld metal is 10.94 mm^2 and area of groove geometry is 6.24 mm^2 . This means that area of melted base metal is $10.94 \text{ mm}^2 - 6.24 \text{ mm}^2 = 4.70 \text{ mm}^2$ and dilution ratio is $(4.70 \text{ mm}^2 / 10.94 \text{ mm}^2) * 100 \approx 43 \%$.

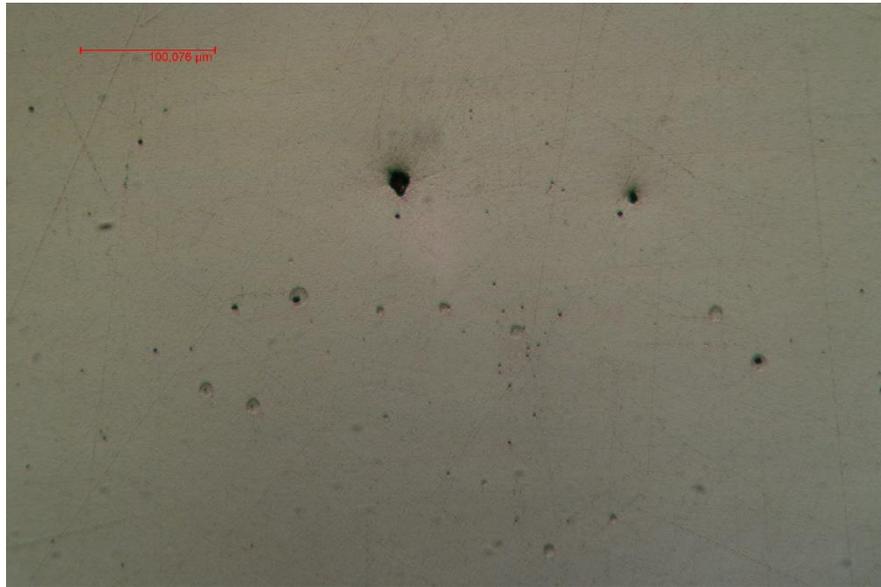
Figure 25. Micrographic image from AS1 base material.

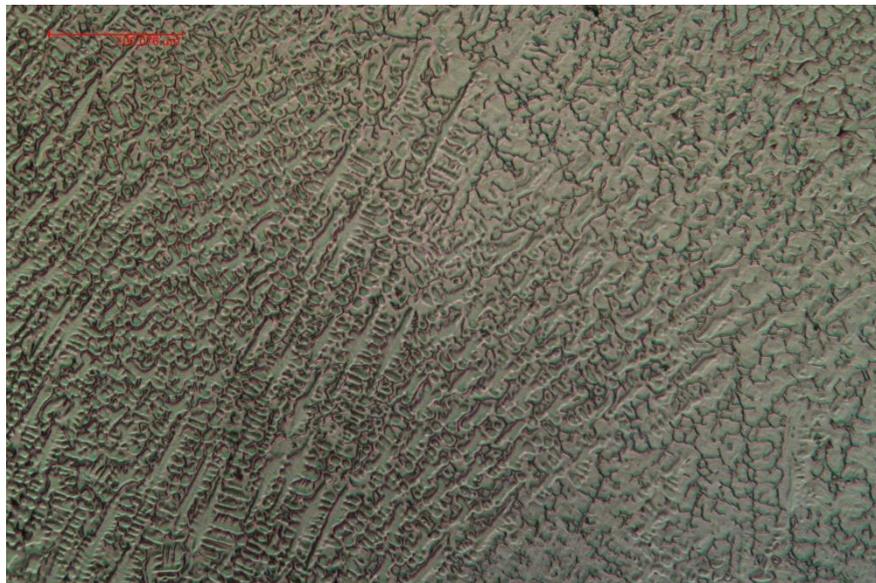
Figure 26. Micrographic image from weld produced to AS1.

be clearly seen. Figure 26 shows the weld material. Weld solidification path can be seen from it

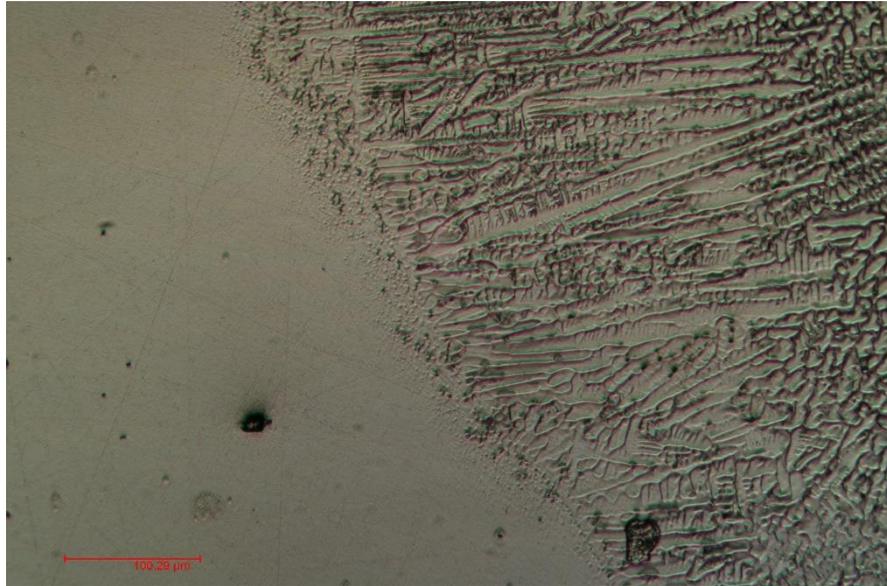
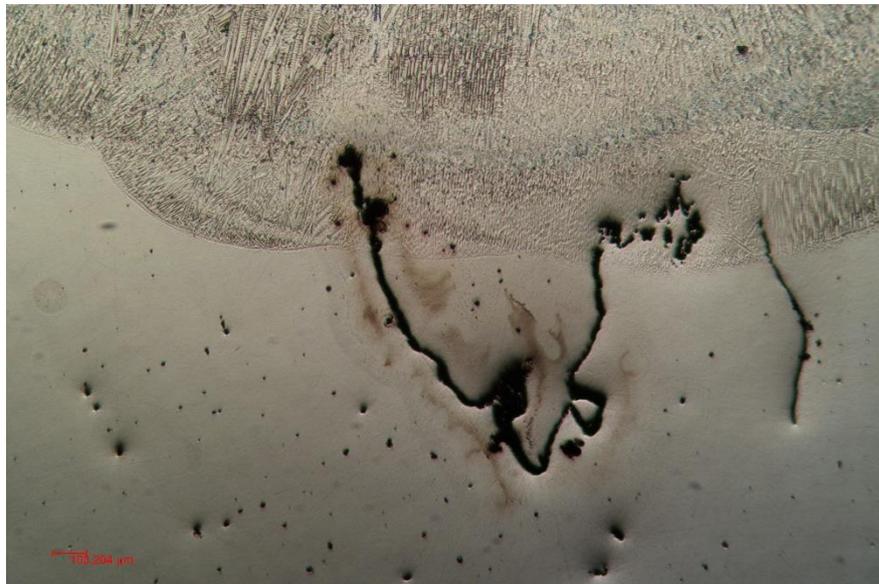
Figure 27. Micrographic image from transition zone between base material and HAZ in AS1.

Figure 28. Crack formed between pore throughout HAZ and base material.

Transition zone of base material and HAZ is smooth in welds examined. Though pores near the transition zone may effect negatively to cracking when located to the both sides of transition zone, compare Figure 27 and Figure 28.

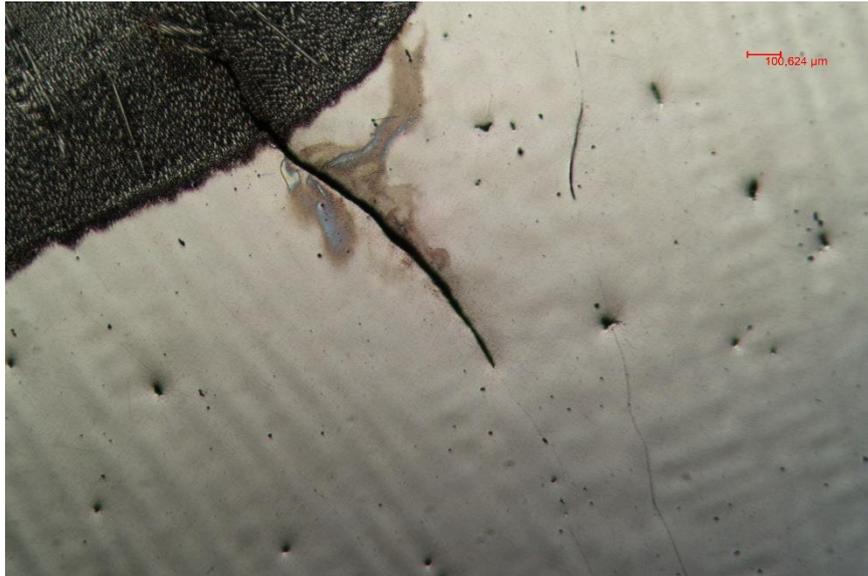
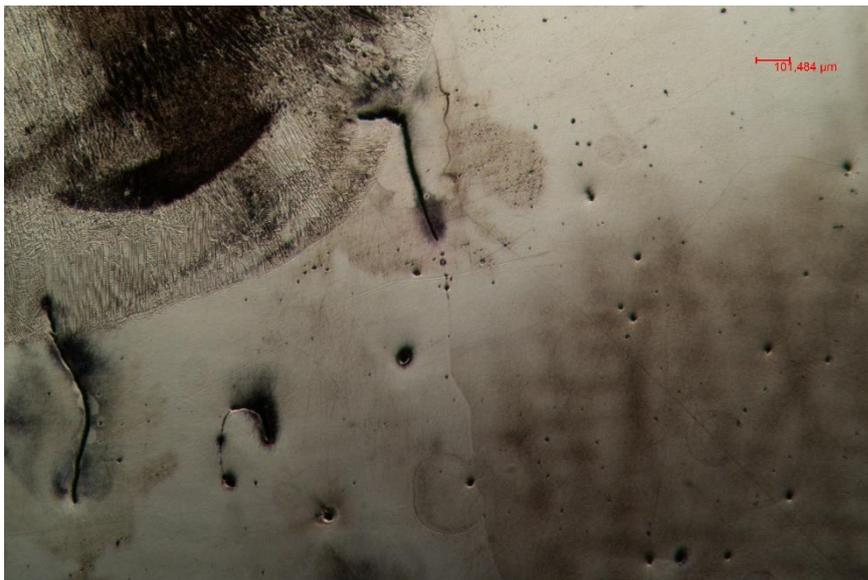
Figure 29. Microscopic image from crack in test weld 6.

Figure 30. Microscopic image from crack in test weld 9.

Finally grain boundaries were managed to get visible with applied etching. Figure 29 and Figure 30 show that cracks are formed in grain boundaries and are continuously propagated into both the base material and across the fusion line in weld metal as well. Heat cycle caused by welding has created thin molten material films to the grain boundaries of base material leading to cracking.

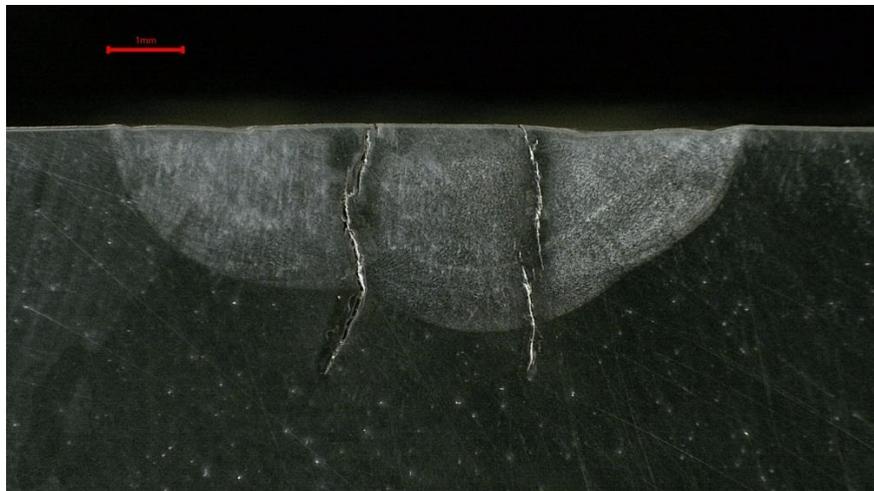
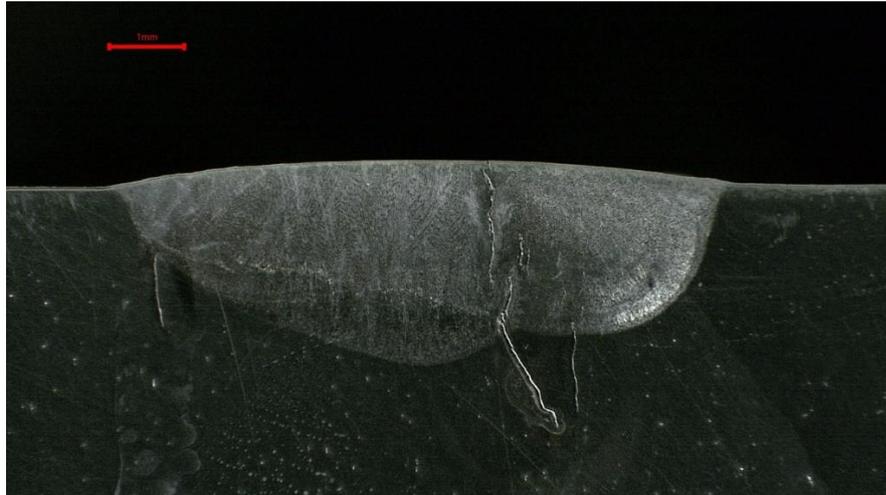
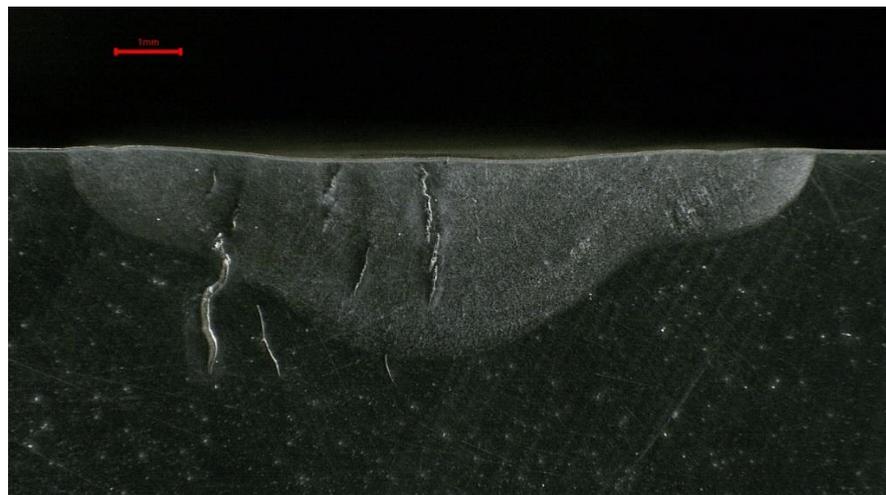
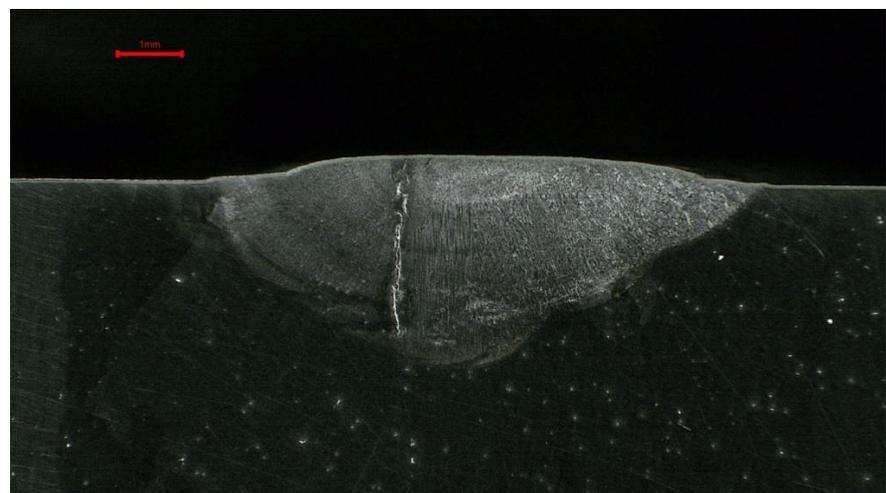
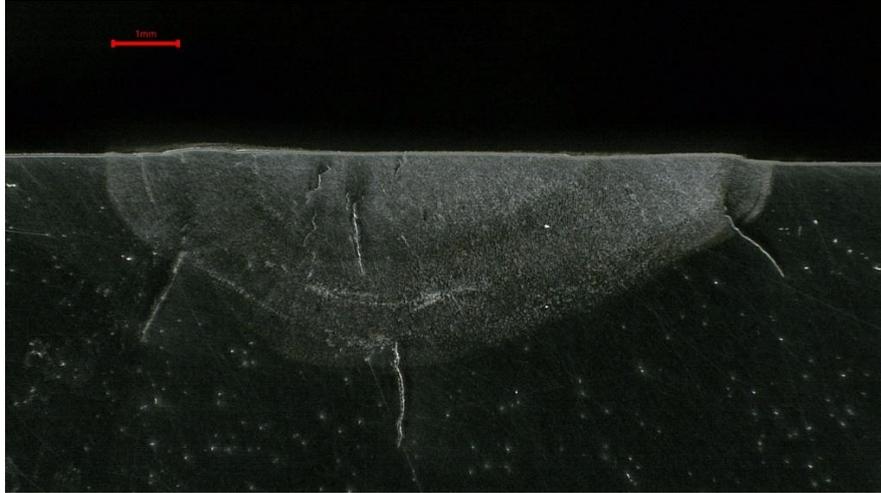
Obvious failures in weld material can be seen at the cross-section images taken from test welds. Welds in which such defects appear were eliminated from the later examinations of parameters to be used in welding of actual pump parts. Following micrographic images presented from Figure 31 to Figure 35 show these welds.

Main parameters used and base materials mixing ratios are listed to the Table 10 presented below. High base material mixing ratio of over 0.50 is common to all the test welds in which failures were found. Variation of 0.37 – 0.77 kJ/mm between test welds was experienced. Though some welds had low calculated heat inputs significant cracking was found in those welds. High base material mixing ratio seems to be the common factor behind the cracking of welds.
