LUT UNIVERSITY
LUT School of Energy Systems
LUT Mechanical Engineering

**REPAIR WELDING OF HIGH ALLOYED AUSTENITIC CAST STAINLESS
STEEL**

Master's thesis

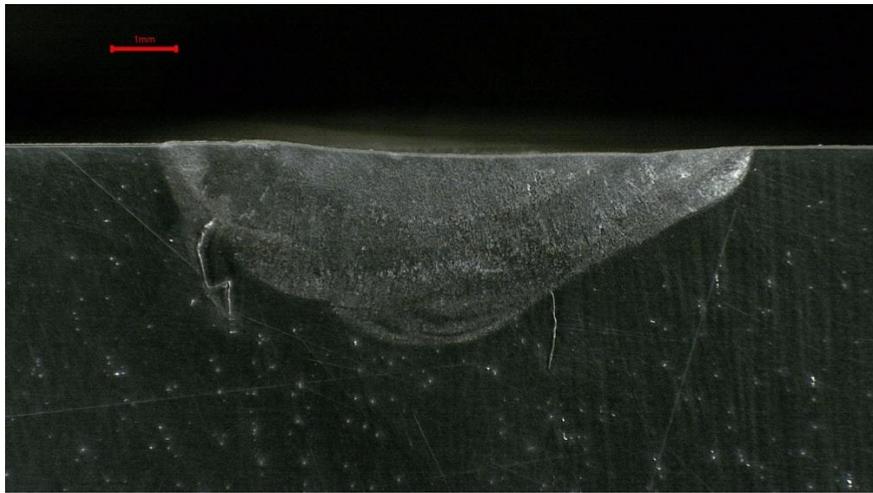
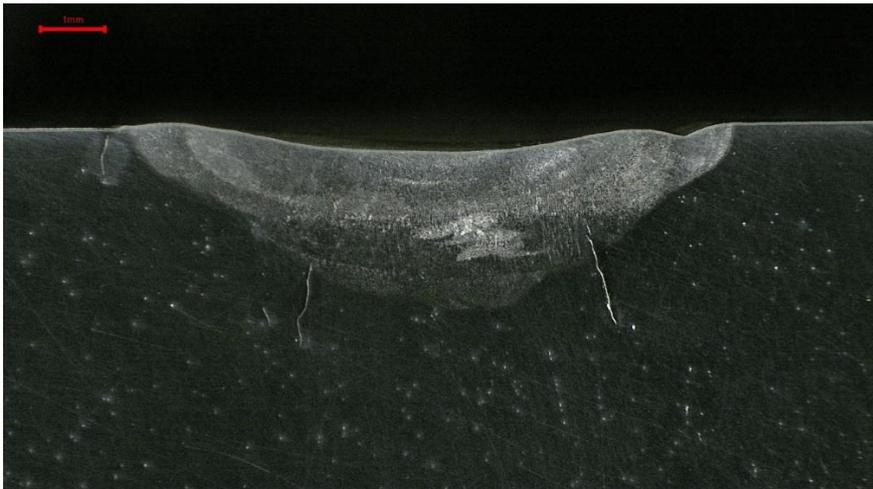
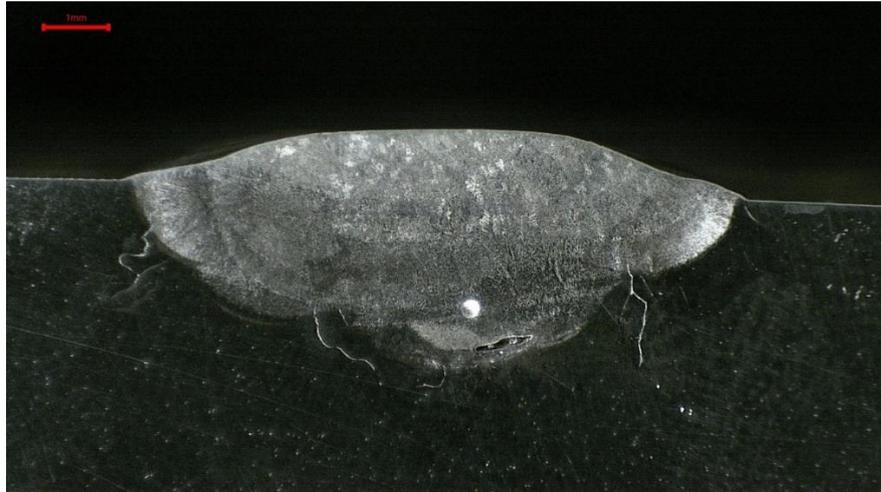
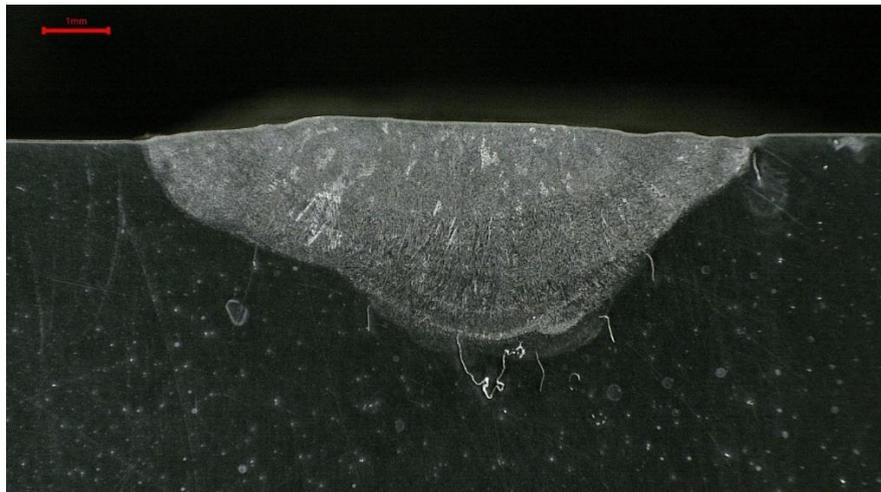
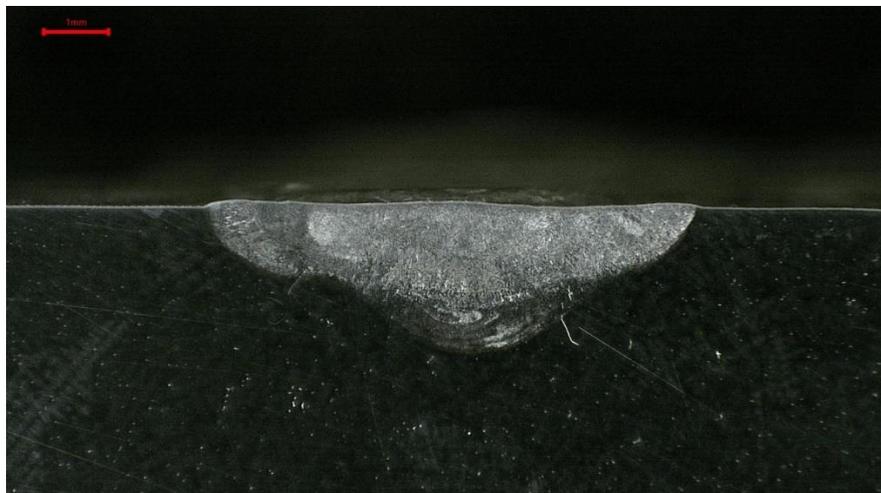
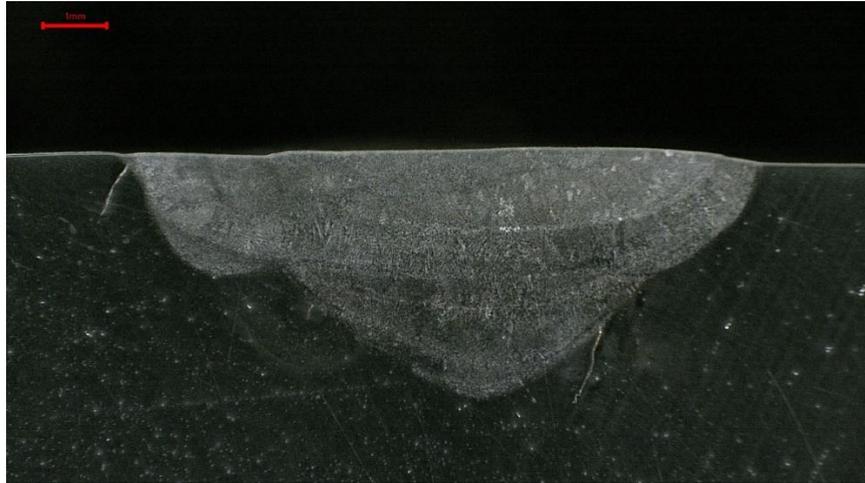
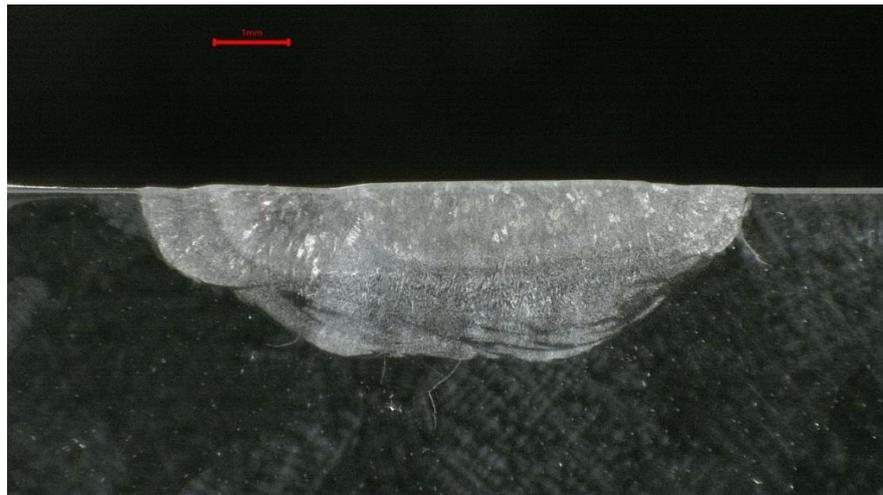
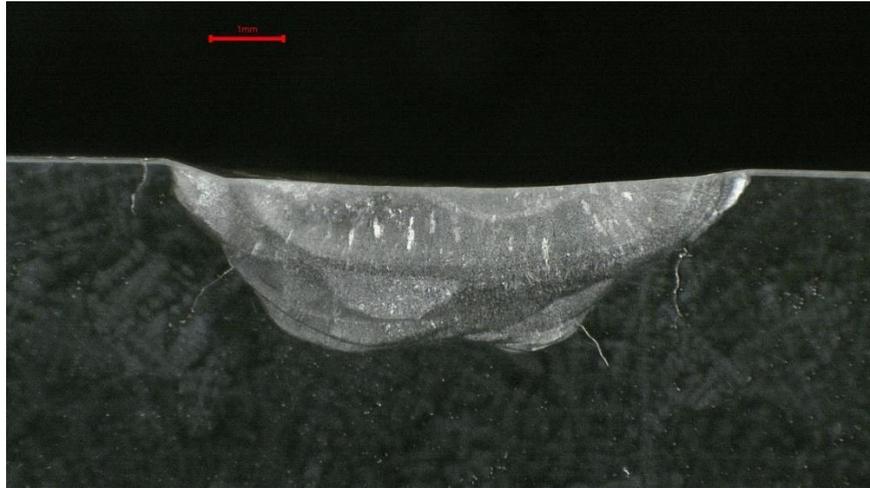
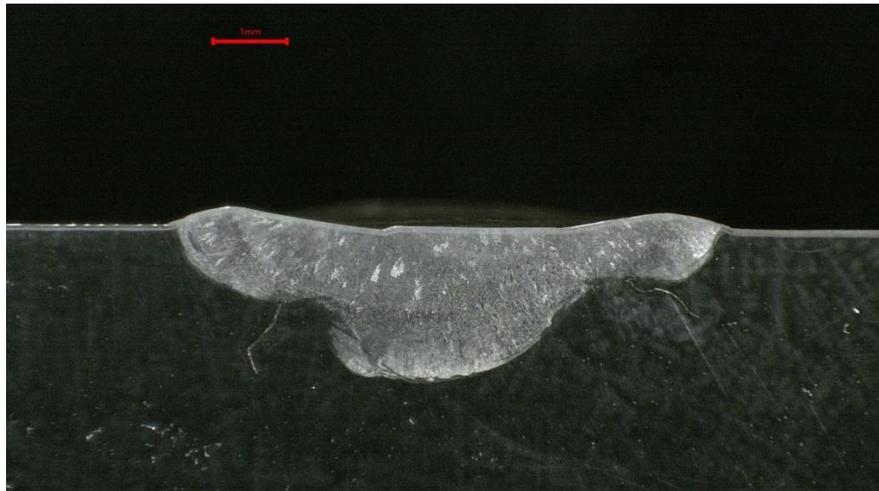
Cross-section images where only small cracks in base material were found and weld metal itself was intact were considered as potential candidates when applicable welding parameters are further assessed. At this point it was clear that due material properties of AS1, liquation cracking in base material will be highly probable even with low heat input and small base material mixing ratio. The above mentioned weld cross-sections are presented from Figure 36 to Figure 44 below.

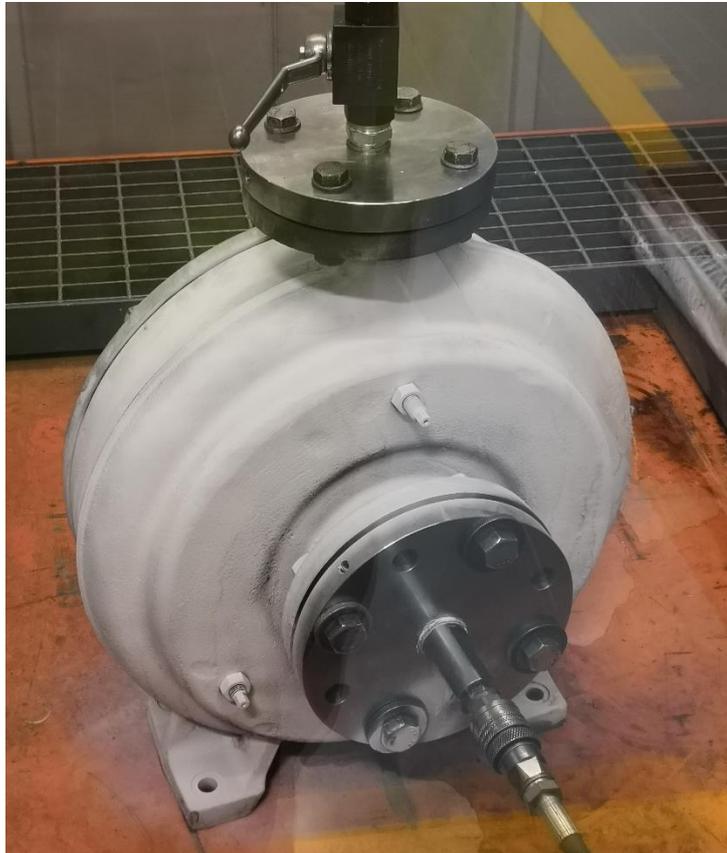
Figure 45. Pump assembled ready for water pressure test.

Pumps casing and backplate were assembled together with bearing housing adapter and pressure testing flanges so that pressure retaining wet end parts could be tested against leakages. Pressure of 24 bars was used. Test is passed if no leaks appear and test pressure remains the same for 10 consecutive minutes. To spot the possible leaks more effectively developer used in penetrant fluid tests was applied for casted parts to be tested, see Figure 45. Leaking spots were then marked, cleaned and welded. After that water pressure test was renewed to check if repairs made stopped the leaks. This procedure without the developer is made for all pumps manufactured at SPFIN.

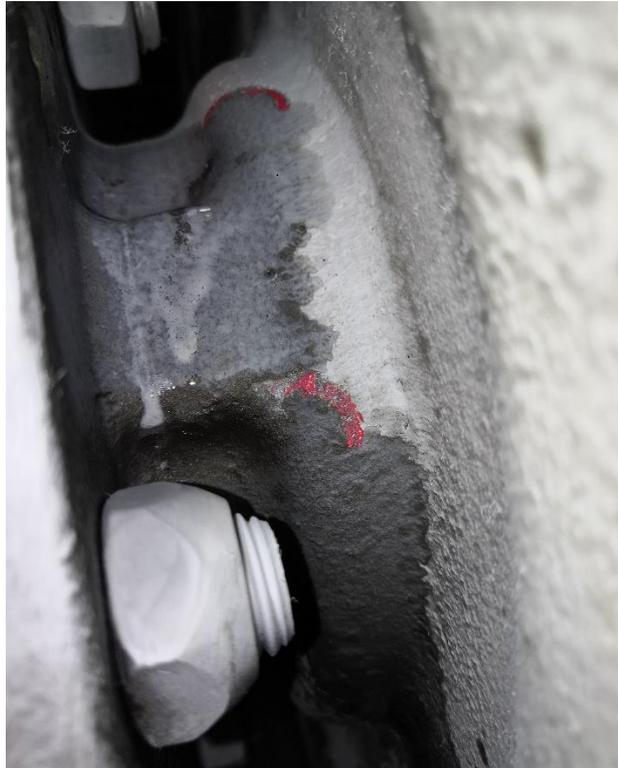
Figure 46. Leaks found during the pressure testing.

Figure 46 shows the two leaking spots found behind suction flange during pressure testing. As these actual leaks are in a spot that is hard to weld decision was made that test welds are made to the side of the casing to a spot where previous penetrant fluid test indicated porosity. This way welding parameters found suitable in laboratory tests could be tested to actual pump casing in a way that similar conditions for welding can be guaranteed for all welds. Parameters used in these tests are shown in Table 13.

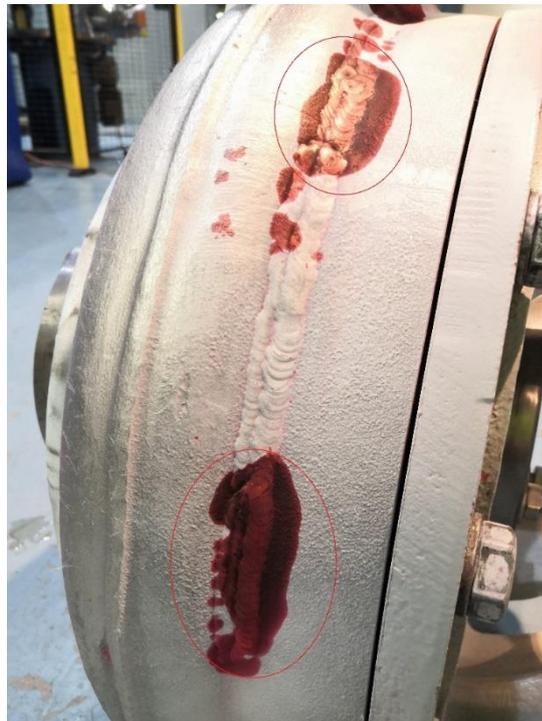
Figure 47. First test welds made to pump casing. Welds highlighted with circle were made by following parameters of pWPS. Other welds that can be seen in the picture were made along the original guidelines of Hurri.

Figure 47 shows the result of first welding tests. As the penetrant fluid test shows, major cracking in welds occurred when pulsed welding with 108 A arc current was applied. Pulse frequency of 1 Hz was used as in laboratory tests where this parameter combination resulted small base material mixing ratio and low heat input. Despite these parameters worked in laboratory tests the outcome of welding actual casing showed exact opposite results as major cracking occurred. There can be multiple reasons for this. different welder handprint causing different base material mixing ratio might be one of those. Other welds shown in the same figure didn't crack. These were made by following original welding guidelines set for the material during the first studies of SPFIN made by Hurri. Constant arc current of 140 A was used for these welds. As can be seen from Table 13 heat input applied to these welds was lower compared to the welds where 108 A pulsed current was used. Main difference was created with higher travel speed between welds. Heat input caused to the casing decreased as welding speed was doubled when compared with 108 A pulsed welding tests. Maximum interpass temperature of 60 °C was used between all the welds.

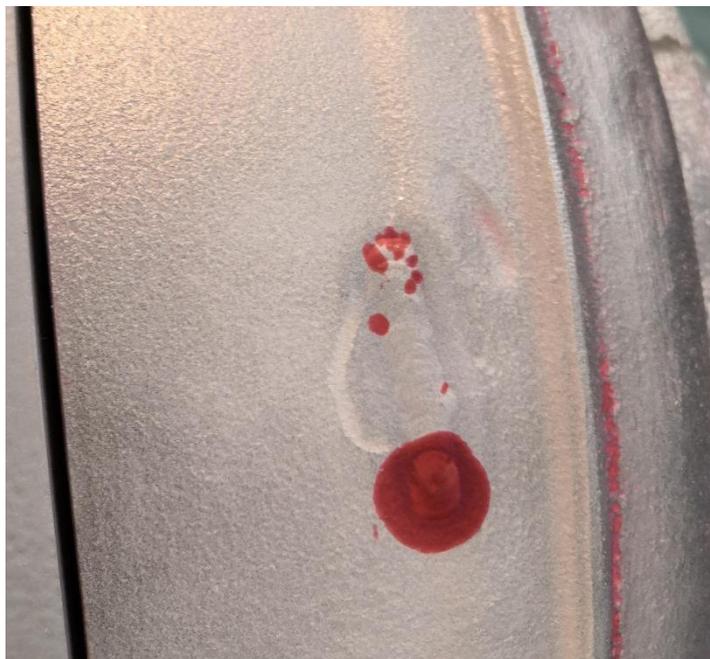
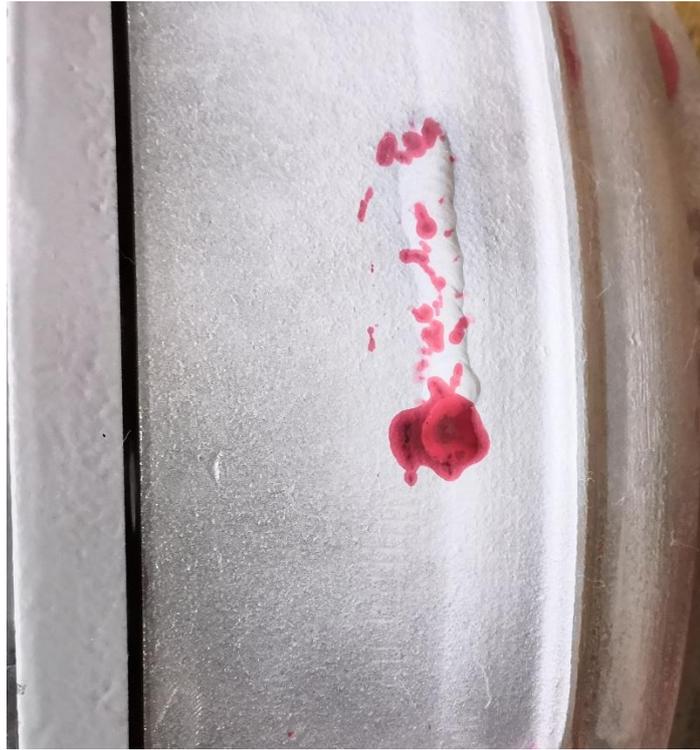
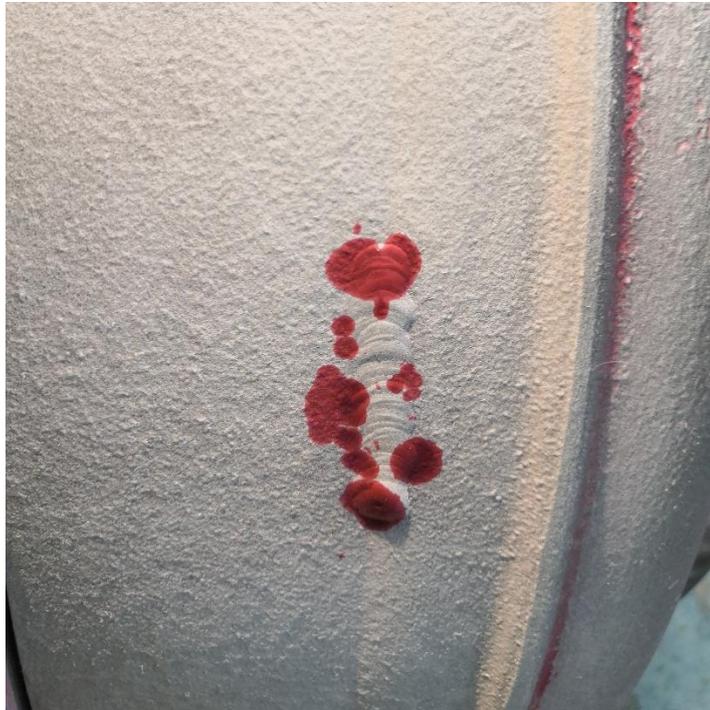
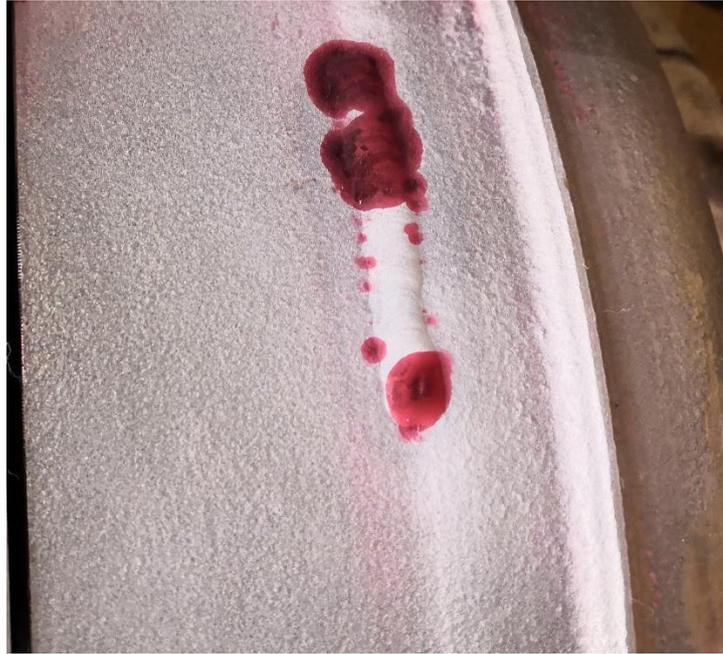
Figure 48. Test weld made with 108 A constant current.

Figure 49. Test weld made with 140 A constant current.

Figure 50. Test weld made with current of 95 A and pulse of 1 Hz.

Figure 51. Test weld made with current of 108 A and pulse of 1 Hz.

As these results were unexpected after the data collected from laboratory tests, more welds were made to the other side of the casing. On that side no porosity was found, welds were again made to similar openings with 6 mm/2 mm width to depth ratio. Intention of these welds was to compare the parameters used in similar conditions once more. Welds were made by using constant current of 108 A and 140 A. Pulsed welding tests were carried out with 1 Hz pulse frequency and welding currents set to 108 A and 95 A. Results of penetrant fluid tests carried out for these welds can be seen from Figure 48 to Figure 51.
