LUT UNIVERSITY  
School of Energy Systems  
Mechanical Engineering

**AFFECTING FACTORS FOR LARGE RADIAL SHAFT SEAL LUBRICANT  
LEAK RATE**

Master's thesis

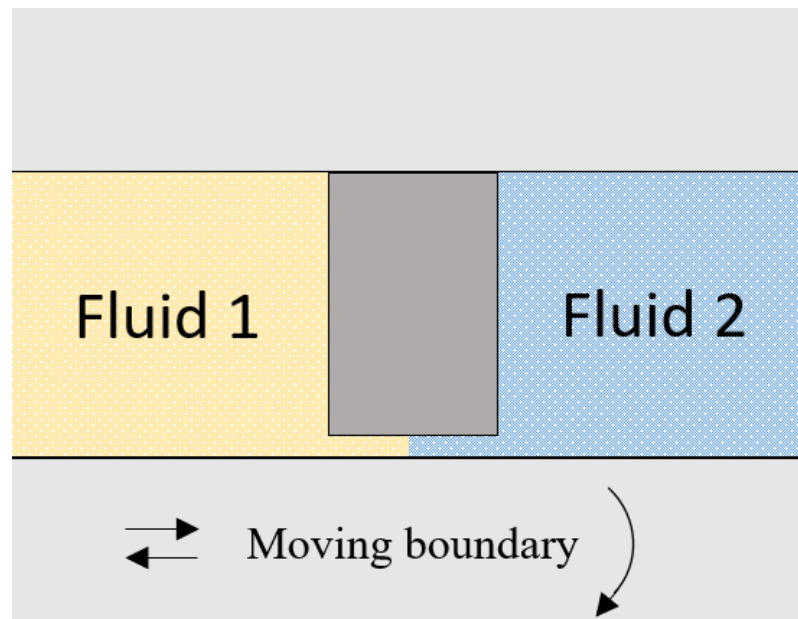
Müller & Nau (1998, p. 1) state the overall sealing problem as "*the control of fluid interchange between two regions sharing a common boundary*". When considering dynamic sealing conditions, as in radial shaft seals, where there is relative motion in the interface of the static and moving component, a small gap will inevitably exist as presented in **Figure 3**. Therefore, fluid molecules will transfer between the regions that are sealed either by diffusion, convection or pressure flow. (Müller & Nau 1998, pp. 1-2.)

**Figure 3.** Sealing problem (Mod. Müller & Nau 1998, p. 2).

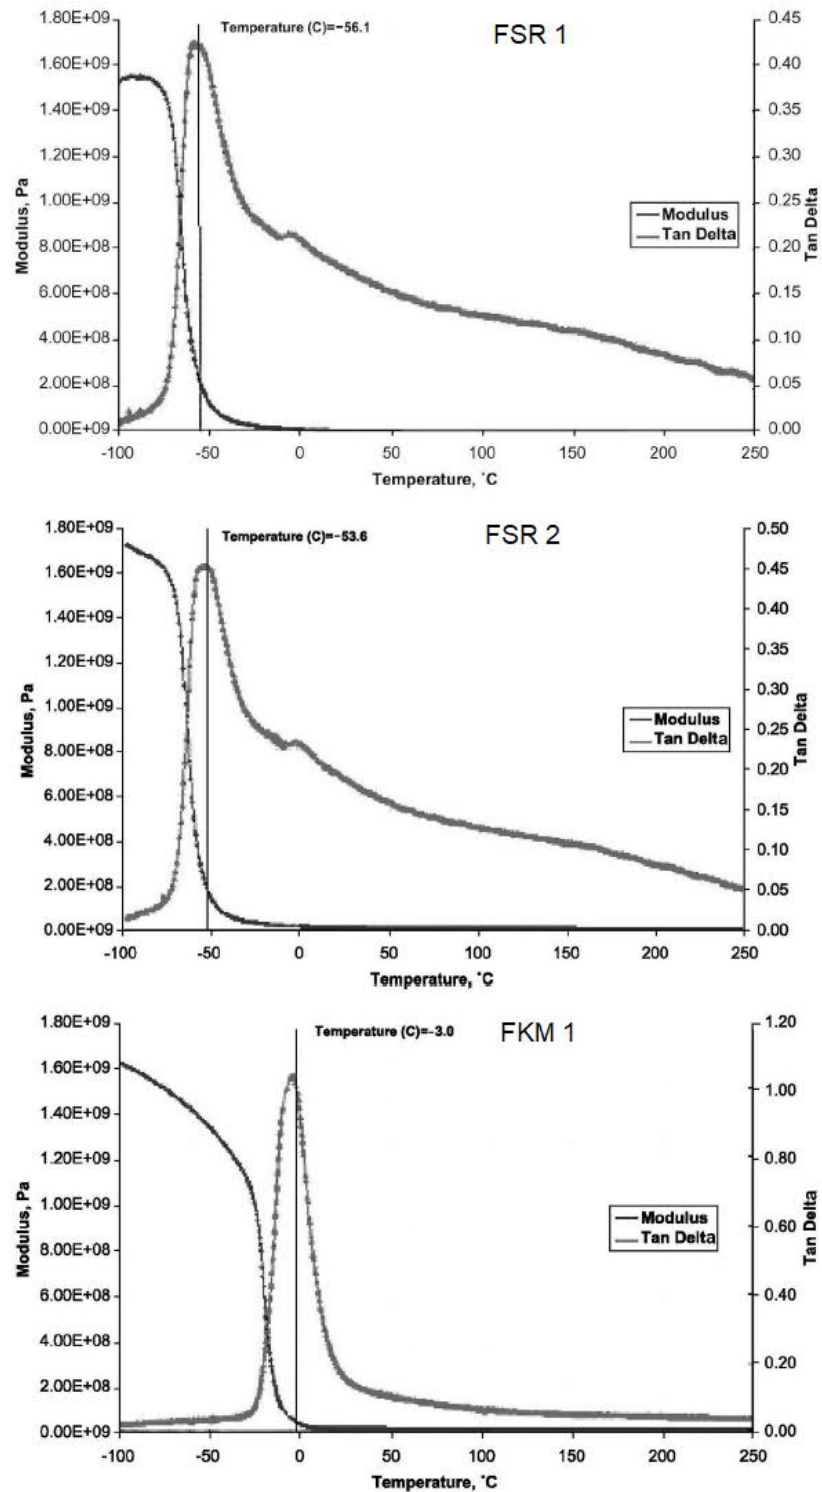
Elastomers have low hysteresis, and they are very resilient at the same time when they are used in a suitable temperature range (Flitney 2007, p. 359). Hysteresis in this context means the difference between energy input and outputs on elastic deformation. Resilience describes the elastomers speed of recovery to its original state after deformation. (James Walker 2017, pp. 5, 43.) These properties provide the sealing rings capability to withstand pressure changes, shaft vibrations and runout (R.L. Hudson & Company 2005, p. 28). Temperature and loading amplitude the elastomer encounters have great effect on the hysteresis loss (Hanhi et al. 2007, p. 12). Hysteresis loss can be represented by variable  $\tan \delta$ , which presents the elastomers ability to absorb and return energy subjected on the material. High  $\tan \delta$  value means that the materials response to changing conditions is worse compared to low  $\tan \delta$  value.  $\tan \delta$  curves show a clear peak at a material specific temperature. On the lower temperature side of the peak, the material has low  $\tan \delta$  value but at the same time the material has become significantly stiffer than in higher temperatures. This means that that the material has reached its glass transition temperature and even though the material is resilient, the strain area it can work with is very narrow as the material is very stiff. (Flitney 2005, pp. 7-9.) Graphs showing two fluorosilicone rubber (FSR) compounds and one fluorocarbon (FKM) compounds modulus of elasticity and  $\tan \delta$  values in the function of temperature is presented in **Figure 5**.

**Figure 5.** Modulus and  $\tan \delta$  of different elastomers retell (Flitney 2005, p. 9).

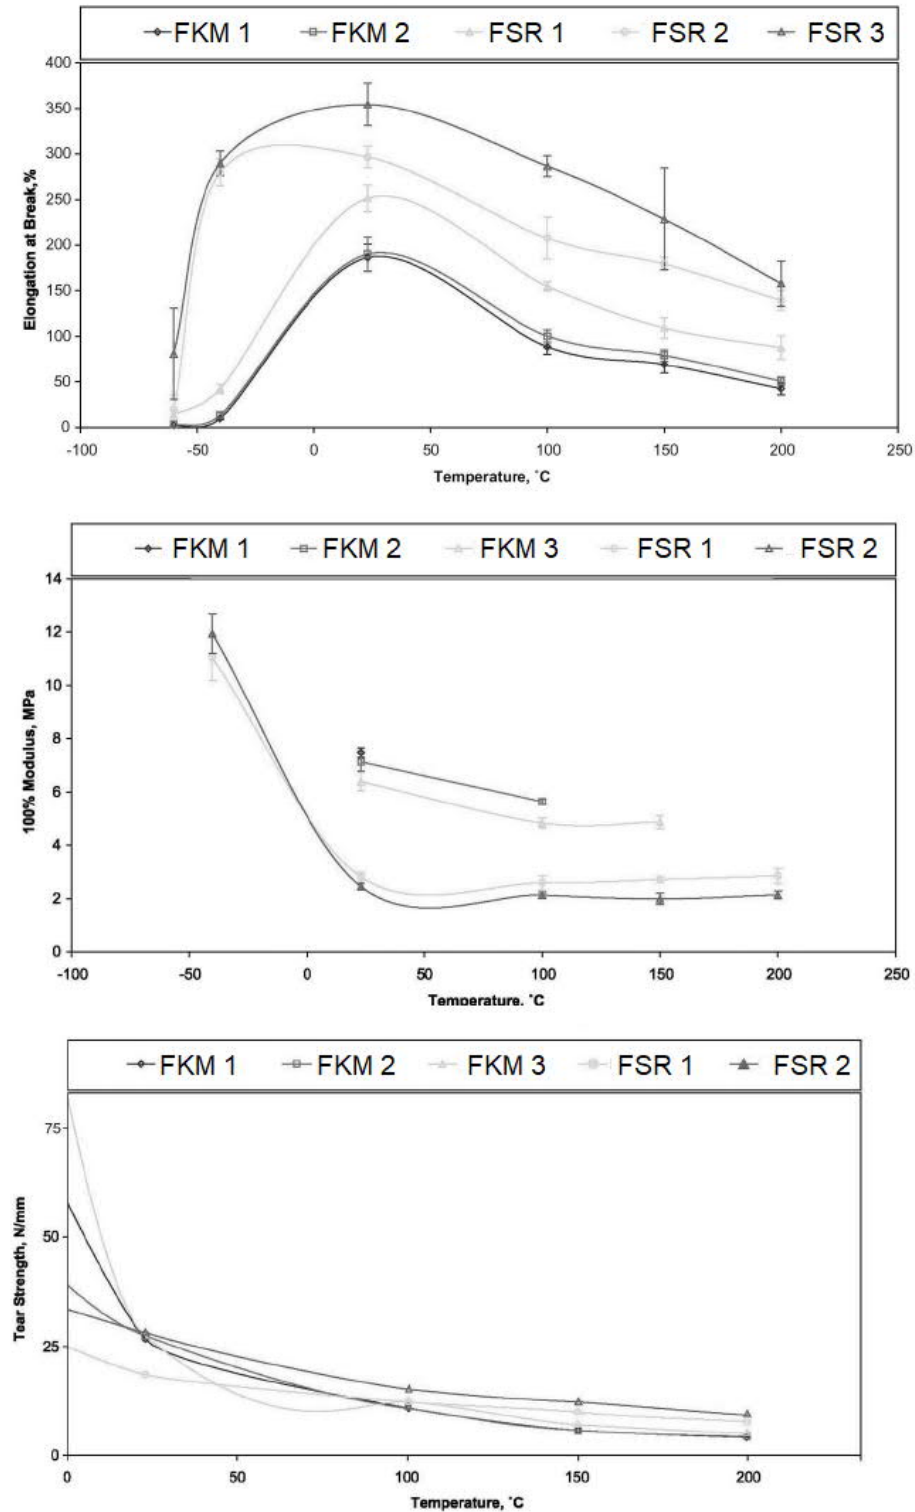
than 100%. (Flitney 2005, p. 7.) Graphs showing different elongation and tear strength properties of same materials shown in **Figure 5** and **Figure 10** are presented in **Figure 11**.

**Figure 11.** Elongation at brake, 100% modulus and tear strength in the function of temperature (Mod. Flitney 2005, p. 8).

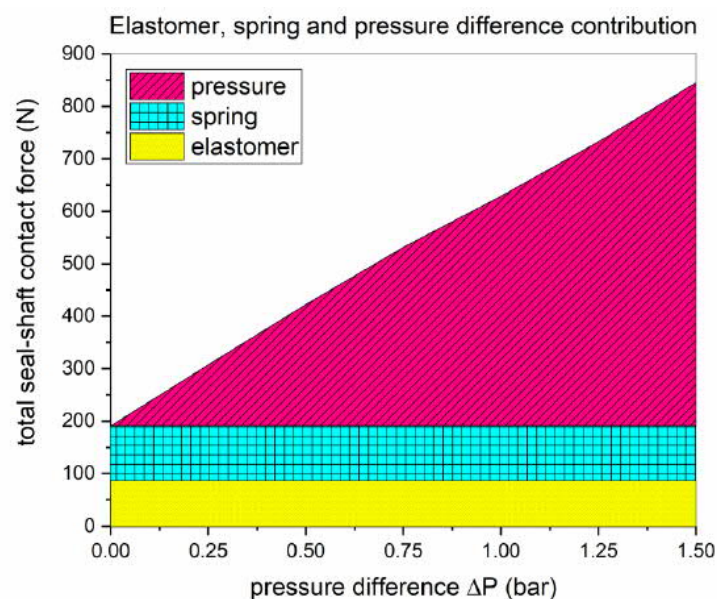
In the study performed by Borrás et al. (2020, pp. 26-27) the influence of the radial force created by the interference fit and the garter spring on the total radial force is larger than the radial force created by the pressure difference over the sealing ring profile until the pressure difference is more than 0,5 bar, which indicates that the interference and the garter spring play a significant role in the contact properties especially when the pressure difference is less than 0,5 bar. A graph showing the radial force in the function of the pressure difference is presented in **Figure 16**.

**Figure 16.** Seal-shaft contact force in the function of pressure difference (Borrás et al. 2020, p. 28).

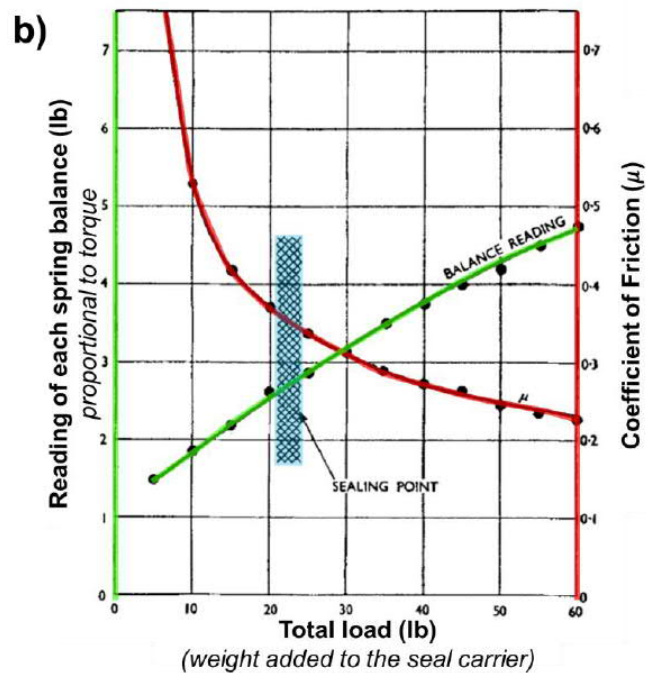
When the sealing mechanism was studied for the first time in the 1950s, it was expected that there would be a dry contact pair between the shaft and the seal, and the seal must cut the lubricant film to enable leak-free contact (Borras 2020, p. 41; Wennehorst 2016, p. 5). However, in one of the first ever tests, it was found that that a significant frictional torque was created between the shaft and the seal even when the radial force was close to zero (Wennehorst 2016, p. 9). The frictional force in a dry contact pair would have been proportional to the radial force, and because this was not the case here, it suggested that the contact between the shaft and seal lip tip is continuously lubricated (Borras 2020, p. 43). One of the first ever tests that aimed to further determine the sealing mechanism were performed with a test rig that allowed the radial load on the seal to be changed. A series of tests with different radial forces were performed so that with lower radial forces the seal would leak. It was also thought that there would be a distinct change in the slope of the frictional torque between a leaking and non-leaking seal, but the testing revealed that such change in slope does not exist. (Borras 2020, pp. 42-43.) Figure showing radial force, frictional torque and frictional coefficient from these tests is presented in **Figure 20**.

**Figure 20.** Effect of radial force on sealability and frictional torque (Borras 2020, p. 43).

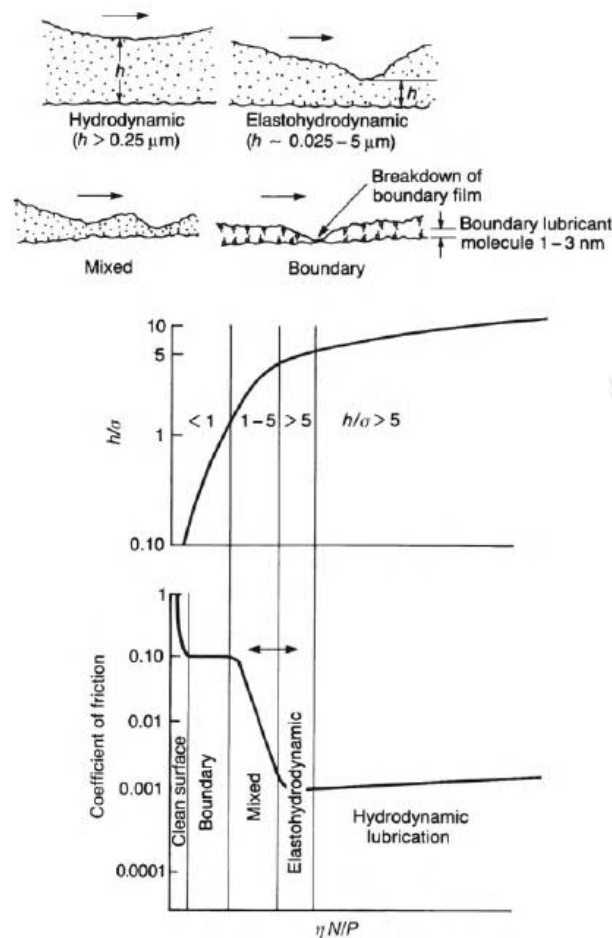
Lubrication regimes in sliding contacts can be divided into four different types – boundary, mixed, elastohydrodynamic and hydrodynamic lubrication. The conditions for each regime is shown in the two graphs on **Figure 21**. The first graph shows the lubrication regime in the function of the lubricant film parameter  $h/\sigma$ . The second graph shows the friction coefficient  $\mu$  as a function of  $\eta N/P$ , and is also known as a Stribeck curve. On the top of **Figure 21** is a visual representation of the different lubrication regimes. (Bhushan 2013, p. 400.)

**Figure 21.** Lubrication regimes and Stribeck curve (Bhushan 2013, p. 400).

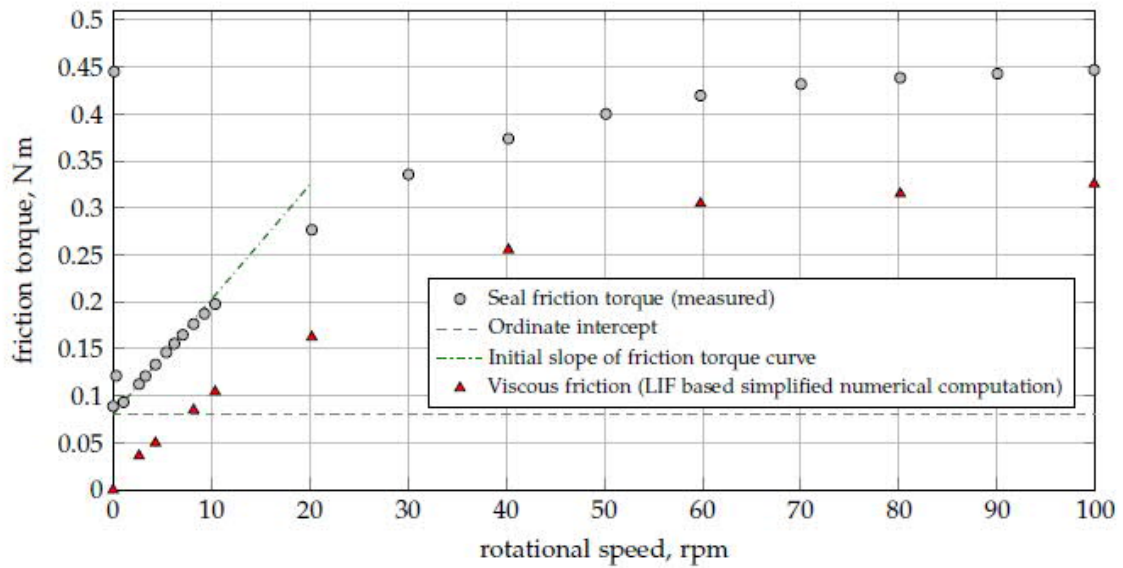
Different studies show similar behavior. Wennehorst (2016) studied the lubrication conditions and lubrication film thickness with different shaft surface speeds. He also measured the lubrication film thickness in different locations on the seal cross-section. As in the test results reported by Horve (1996, pp. 187-190), the tests performed by Wennehorst (2016) show that the friction coefficient starts from a non-zero value, which strengthens the conclusion that the frictional force of the seal is determined by a constant and velocity dependent terms (Borras 2020, p. 46). A graph showing the frictional torque in the function of rotation speed based on tests performed by Wennehorst (2016, p. 72) is presented in **Figure 25**.

**Figure 25.** Friction torque in the function of rotational speed (Wennehorst 2016, p. 72).

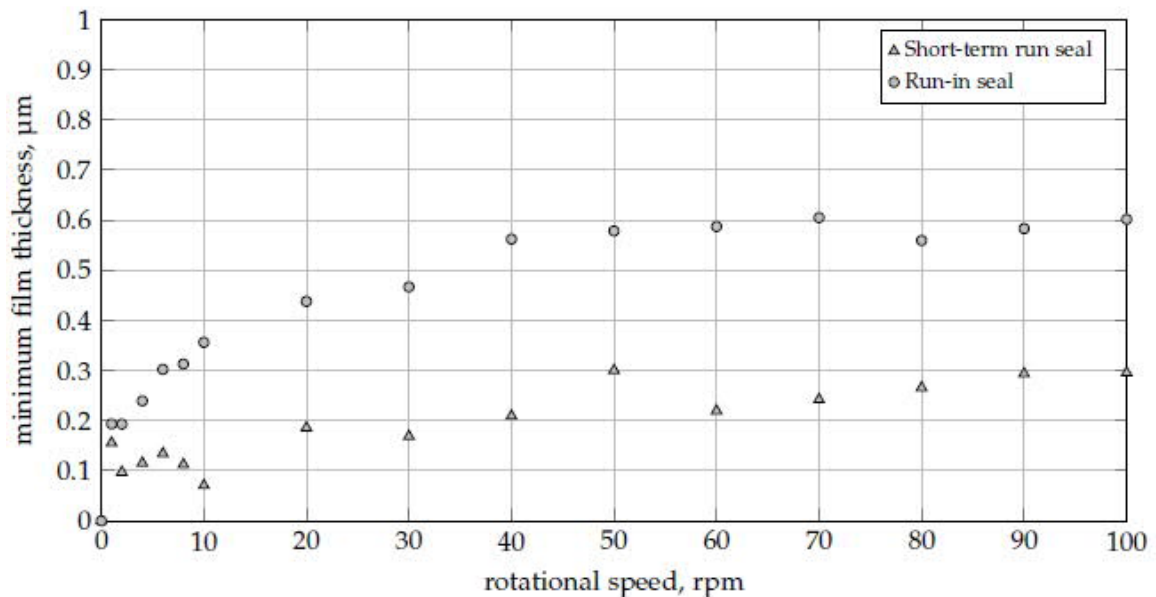
Seal material	FKM
Shaft diameter [mm]	82
Oil	Mineral
Oil kinematic viscosity at 40°C [mm <sup>2</sup> /s]	172
Oil pressure	N/A
Sump level	N/A
Contact width [mm]	approx. 0.15
Oil sump temperature [°C]	20-30
Radial load [N/mm]	0.0555

**Figure 26.** Minimum lubrication film thickness in the function of rotational speed (Wennehorst 2016, p. 57).

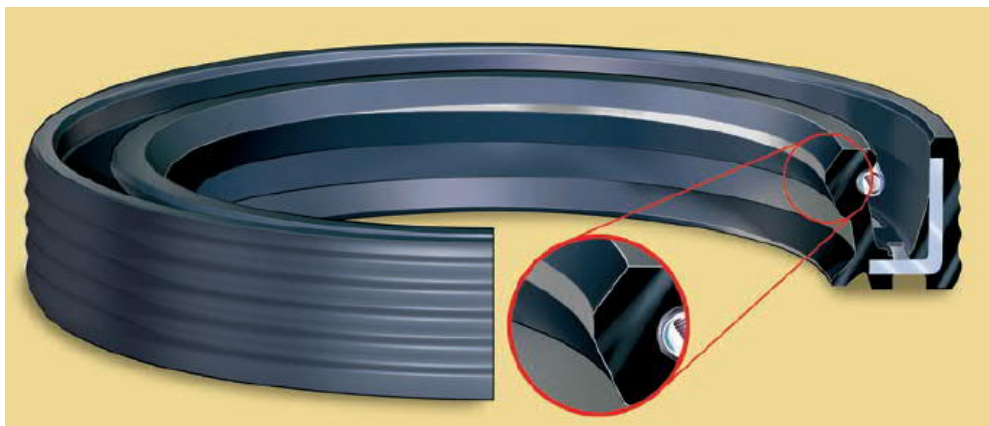
**Figure 43.** Unsymmetrically worn seal (R.L. Hudson & Company 2005, p. 226).

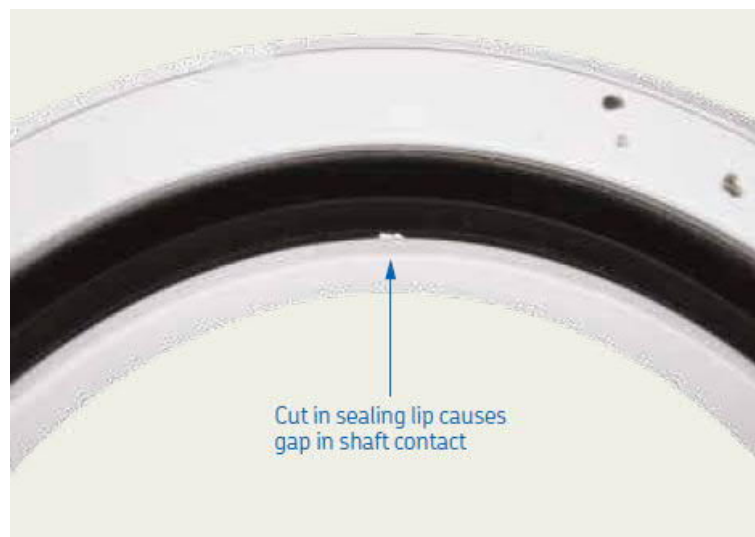
**Figure 46.** Cut seal surface (SKF 2019, p. 50).

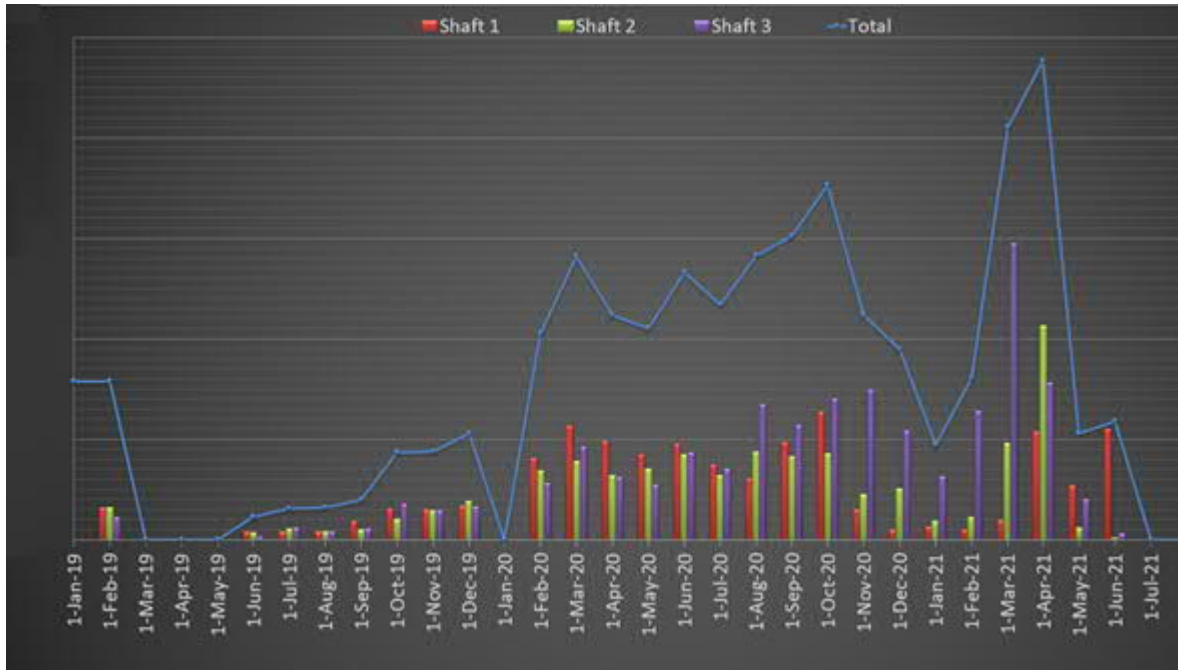
**Figure 57.** Lubricant leakage rate from an operating vessel.

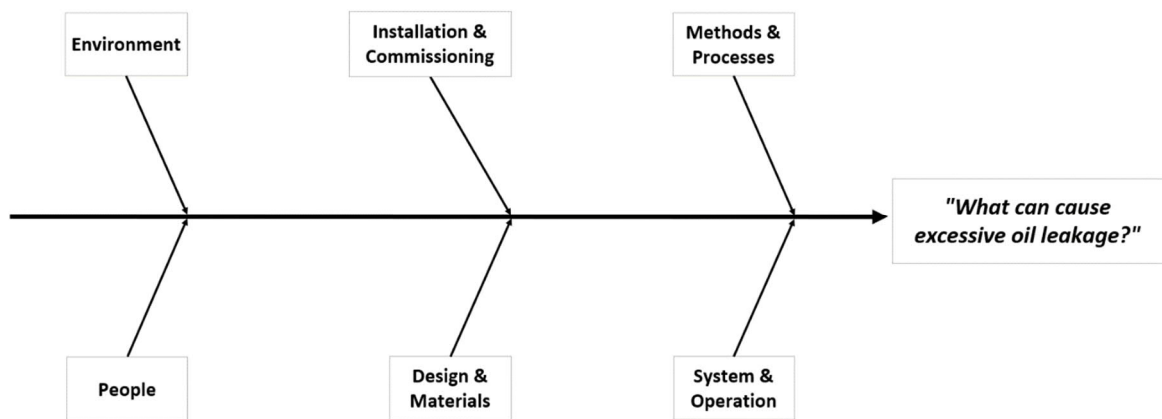
**Figure 60.** Upper-level cause-and-effect diagram.

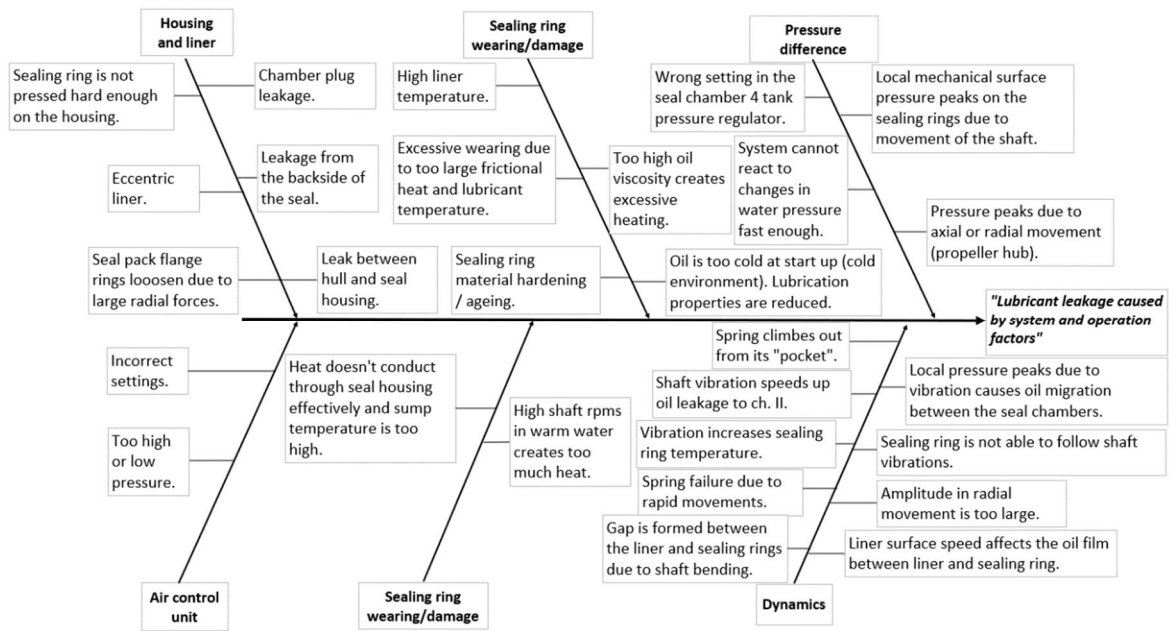
**Figure 62.** Cause-and-effect diagram, simplified system and operation.

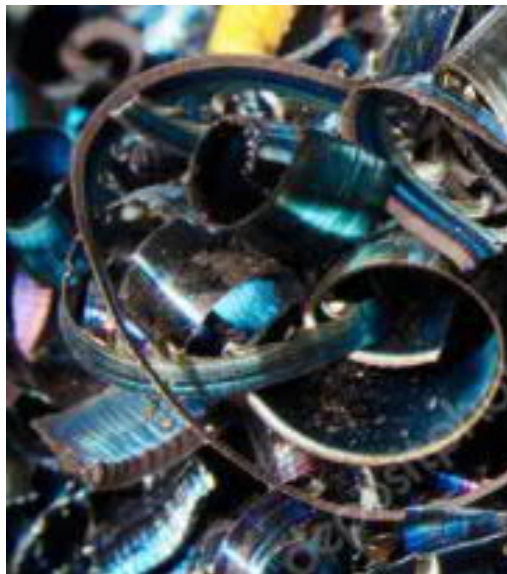
**Figure 64.** Machining chips between housing rings.

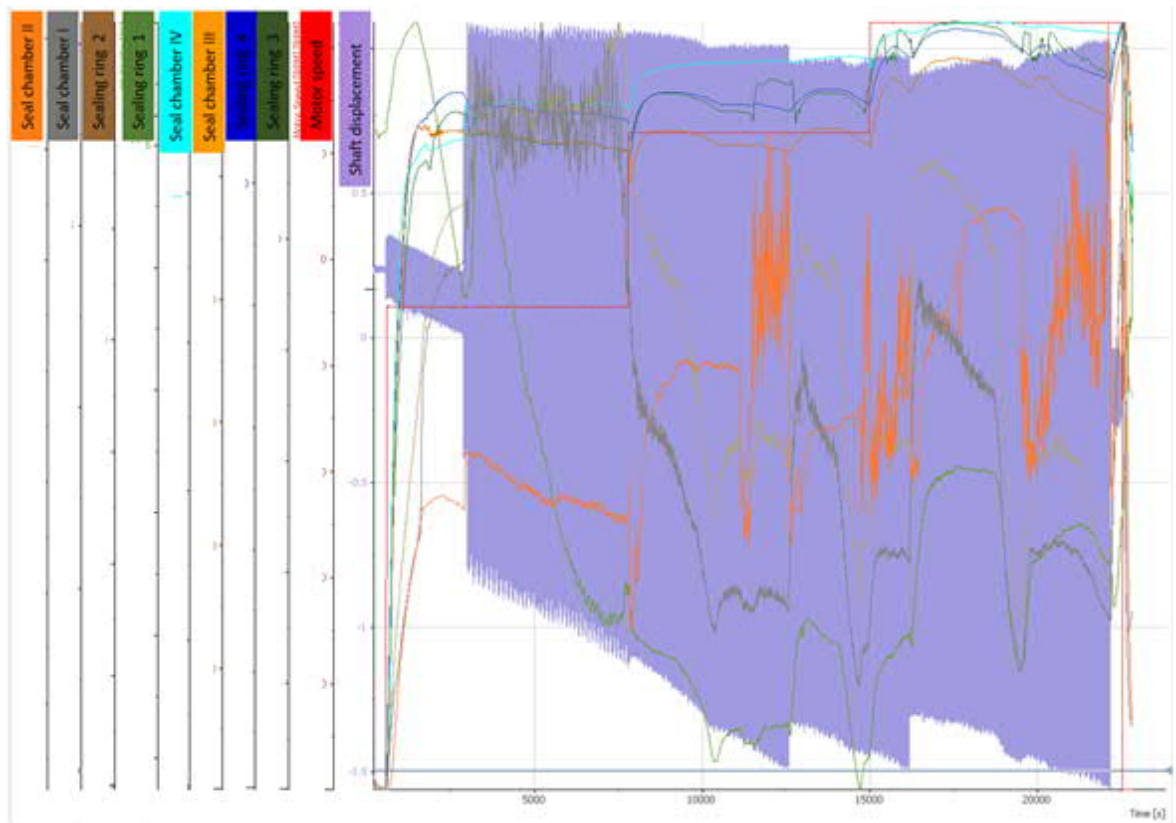
**Figure 81.** Seal system response to constant vibration amplitude with changing shaft speed,  $\Delta p 0,4$  bar over sealing ring 3.

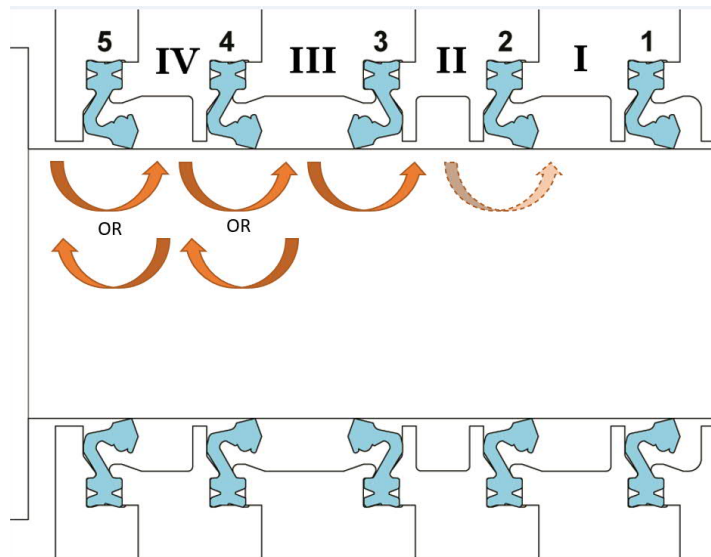
**Figure 91.** Possible directions of oil leakage.
