**DEVELOPMENT OF PAPERBOARD CUP MANUFACTURING CHAIN  
MONITORING AND ANALYSIS**

Master's thesis in mechanical engineering

2023

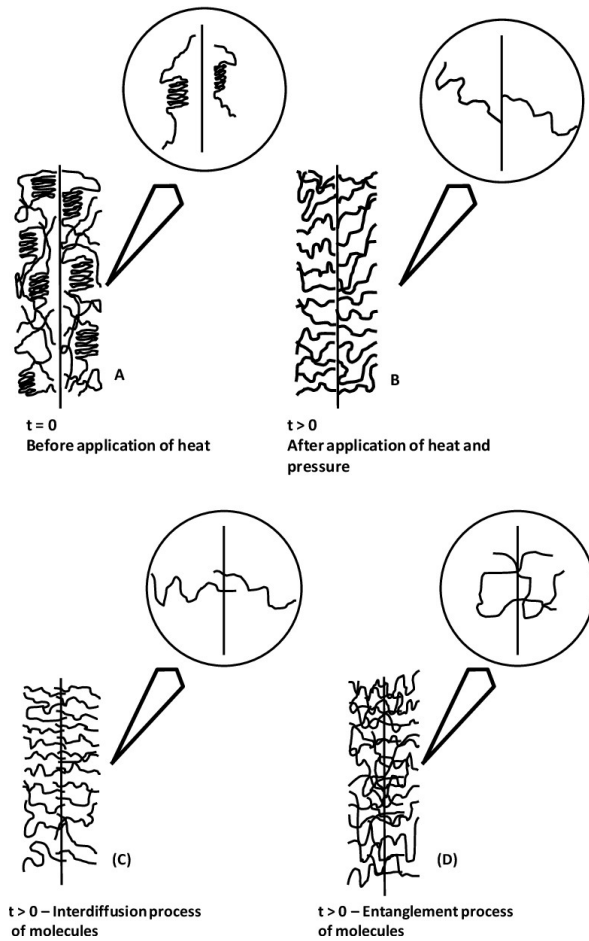
In the side seaming stage, heat, pressure, and time are used to create a lap seam by wrapping the blank around a tapered cylinder, the mandrel, and applying pressure to the overlapping surfaces to form the walls of the cup. Since no glues are used in modern, single walled disposable cups, the seal is formed by bringing the polymer barrier coating on the seam surfaces of the blank to a molten state, usually by using hot air or flame. The heated surfaces are then pressed together and allowed to cool briefly, recrystallizing the polymers, and finishing the side seam. The molecular principle of this process is presented in Figure 2. When using single-side coated paperboard, the molten coating adheres to the uncoated fiber surface of the blank instead of bonding with the molten coating on the other side.

Figure 2. Molecular principle of heat sealing (Mihindukulasuriya, 2012)

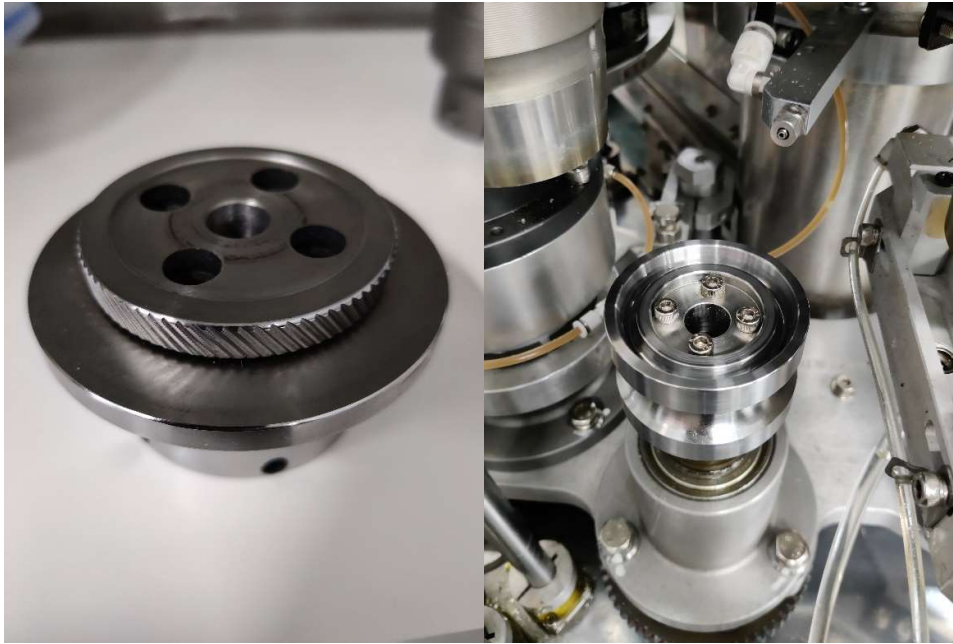
Steps C and D in the previous figure are vital to the seal forming process and can be disrupted if incorrect parameters are used. As the side seal is being formed, bottom blanks are punched from a web of paperboard bottom stock and inserted into molds. As the previously seamed cup bodies arrive at the next station, they are pushed onto the molds with the bottom blanks inside, followed by bottom heating in preparation for bottom curling and knurling. Examples of the tools used for these stages are presented in Figure 3.

Figure 3. Left: Patterned knurling tool. Right: Curling station (LUT packaging laboratory)

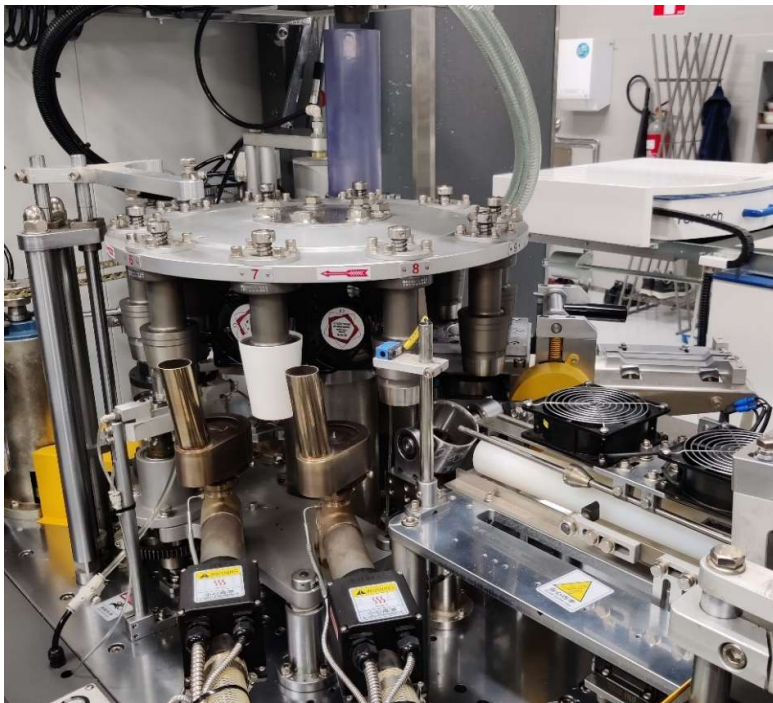
Figure 10. Cup travelling in a mold perpendicular to the horizontal revolver, situated between the bottom heaters. The side seams are cooled by fans before entering the bottom forming steps.

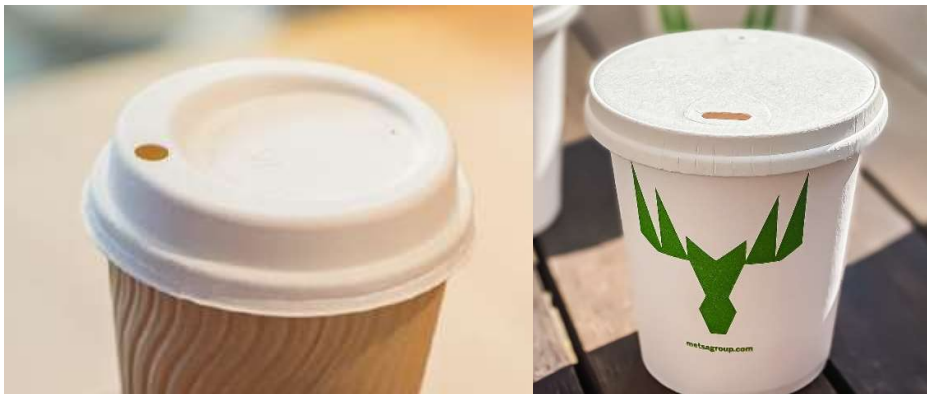
Figure 11. Left: Bagasse based cup lid (Huhtamäki). Right: Paperboard based cup lid (Metsä group).

Companies offering fiber-based materials or converted products like Huhtamäki, Stora Enso and Metsä board have started bringing their fiber-based lid materials and solutions to the market, which are claimed to be plastic-free and easily recyclable alongside paper cups. Examples of two different fiber-based cup lid types are presented in Figure 11.

The materials used for the lids are dispersion coated, recyclable paperboard or molded natural fibers derived from wood and bagasse, which is a by-product of sugar production. (Packaging Europe, 2022).

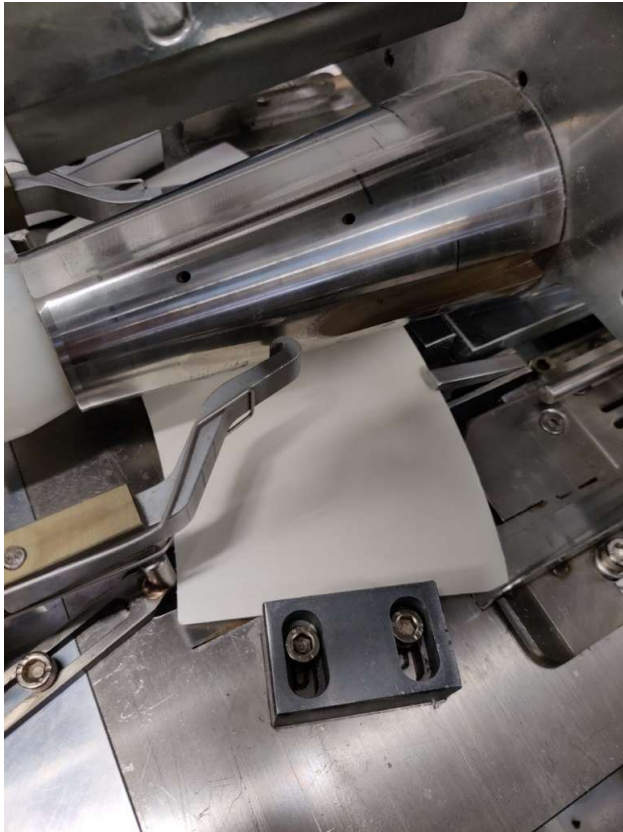
In addition to process parameters, some mechanical adjustments also affect the sealing of the side seam. The placement of the blank on the hot air jets prior to sealing is controlled by a set of adjustable fingers that push the blank forward. A similar set of push fingers which move the blank to the heaters to the sealing station can be seen in Figure 12, on the right side of the blank.

Figure 12. Blank positioning tools used for side seam sealing.

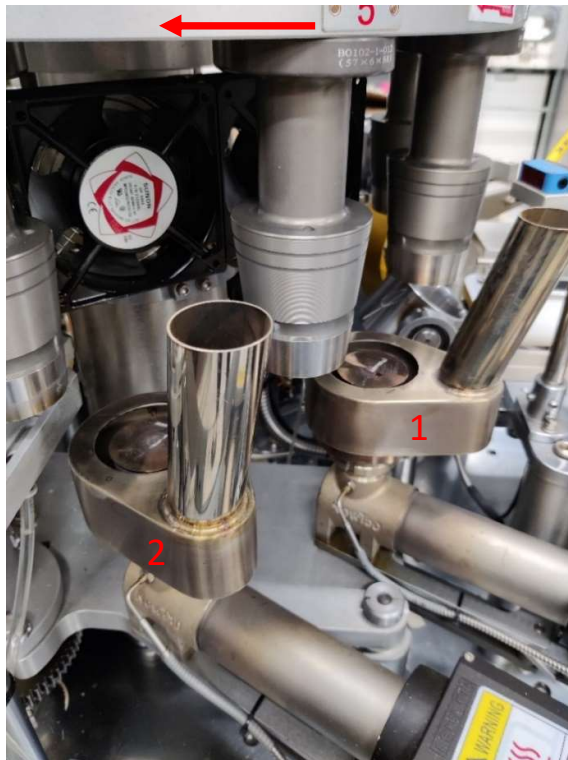
The bottom forming stage can be controlled by adjusting the bottom heating temperature and the height of the bottom curling and knurling tools. The force of the knurling tool is also adjustable. Before the curling and knurling tools, the cup bottom (inside the molds) and bottom part of the cup body are briefly inserted into stations heated by hot air in preparation for the bottom forming steps. The area of the cup wall affected by the bottom heating stations can be controlled by adjusting the station's height. The heating stations are presented in Figure 13 and marked with (1) and (2) according to the process direction.

Figure 13. Bottom heating stations. The direction of rotation is marked with a red arrow.

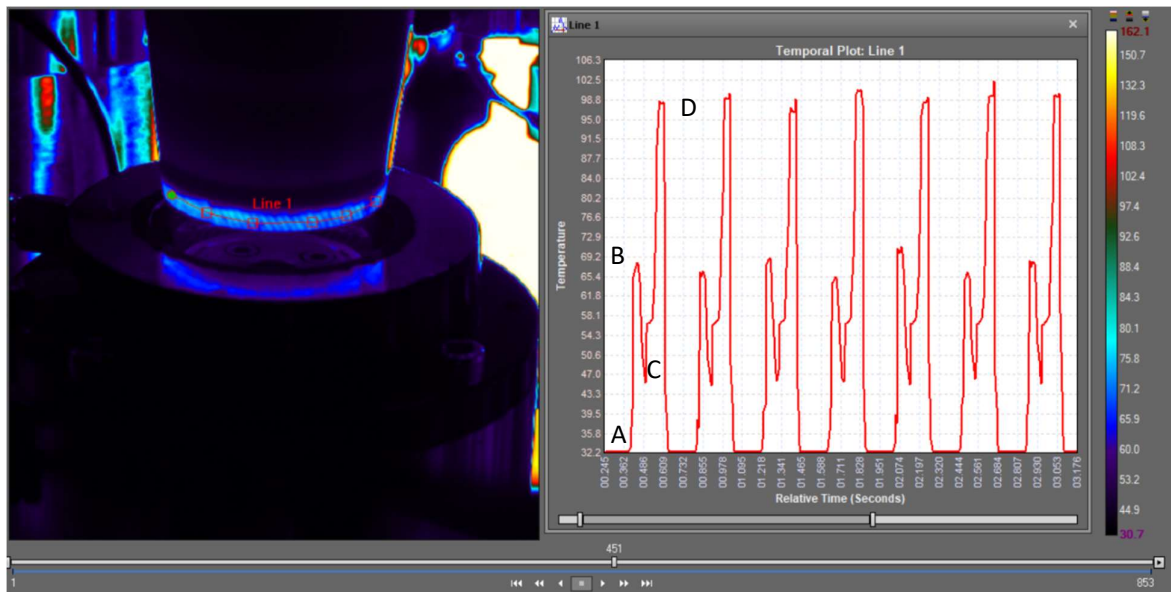
As heat is a necessary component in forming seals in cups, thermal monitoring is an obvious way of acquiring information and evaluating the performance of the process. One method of applying thermal monitoring to the manufacturing chain is using a thermal camera to track the heating tools and heated blanks during seal forming. A Flir A8580 MWIR (FLIR, Wilsonville, USA) thermal camera was used to capture thermal footage of the process. The thermal footage can be used to evaluate the temperature of the cups/blanks in relation to the used parameters and to improve tool adjustments during the forming stages. The benefit of thermal imagery is limited in observing ultrasonic sealing, however, as the ultrasonic vibrations heat the seam surfaces from the inside during the dwell time of the sonotrode, making it impossible to track actual sealing temperatures. An example of thermal camera footage is presented in Figure 14, which shows the temperature of cup bottoms during the knurling step.

Figure 14. Temperature of cup bottoms during knurling (Approximate temperatures: A: 32 °C, B: 69 °C, C: 45 °C, D: 99 °C).

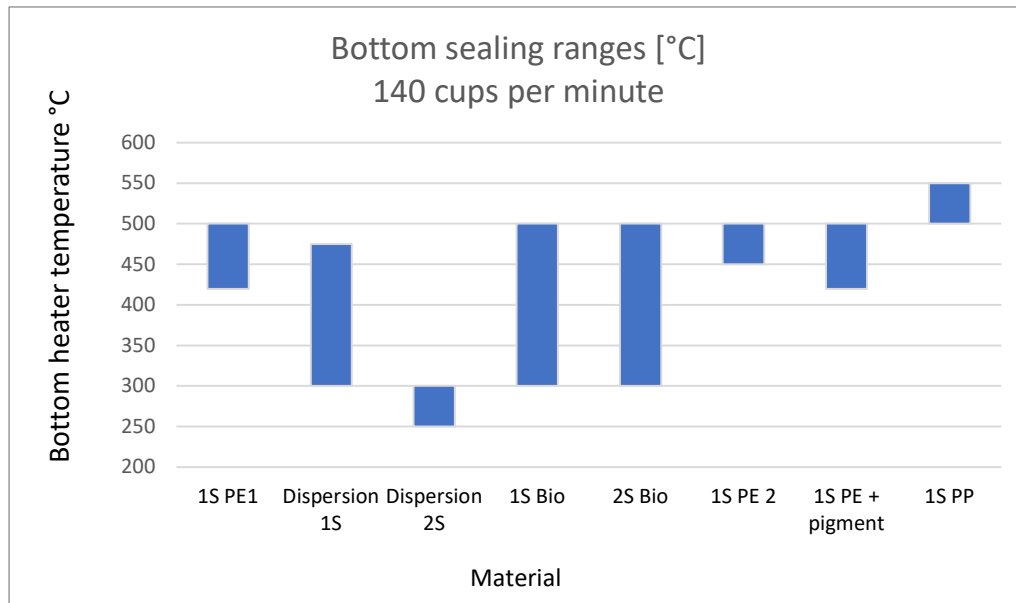
Figure 18. Sealing temperature ranges used to reach a full fiber tear in the cup bottom, excluding 2S dispersion, which only reached a partial fiber tear.

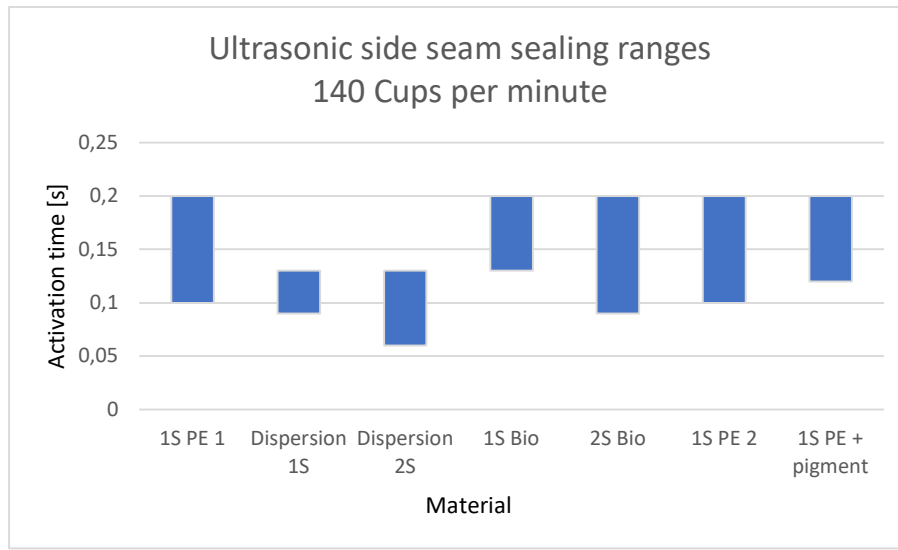
Ultrasonic sealing was tested in activation time ranges of 0.05 to 0.20 seconds at a production speed of 140 cups per minute. For all materials, the optimal sealing time was found in between 0.10 and 0.20 seconds. The activation time ranges for the reference materials can be found in Figure 19.

Figure 19. Ultrasonic activation time ranges used to reach a full fiber tear in the side seam, excluding the two-sided dispersion material, which only reached a fiber tear.

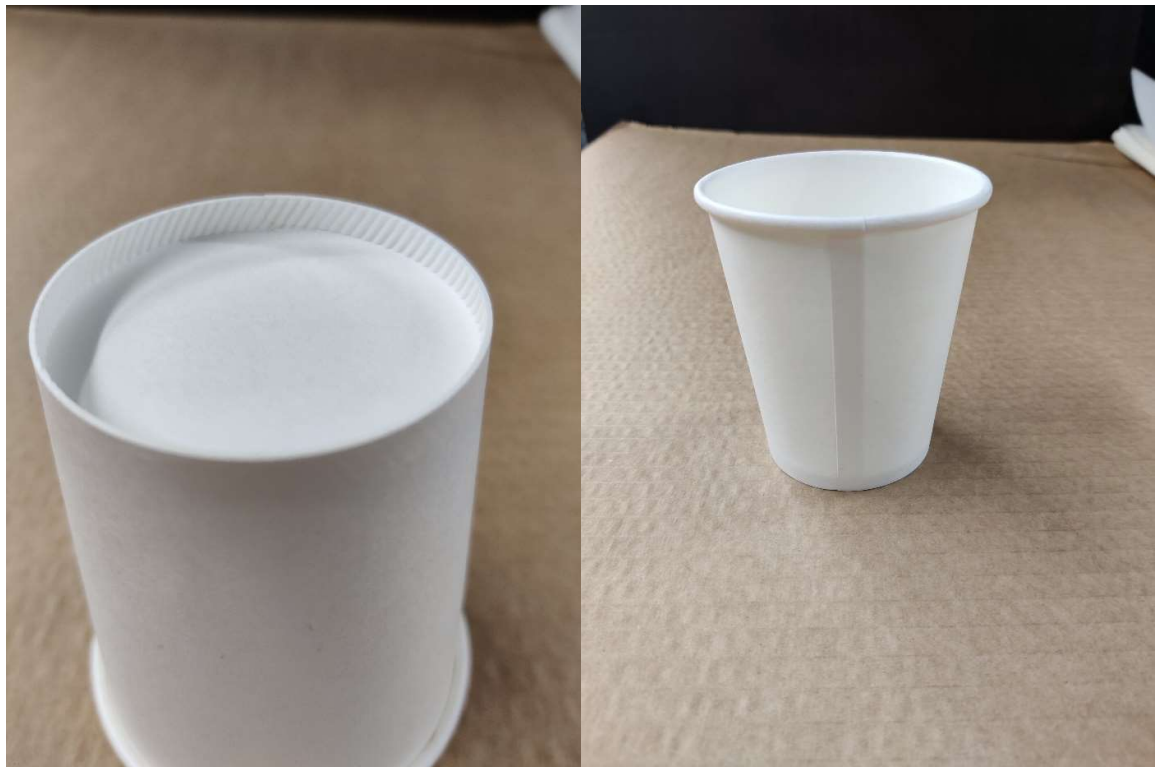
Figure 20. A cup formed from experimental material 3. The dimensions are within the set tolerances and the cup has no visible defects

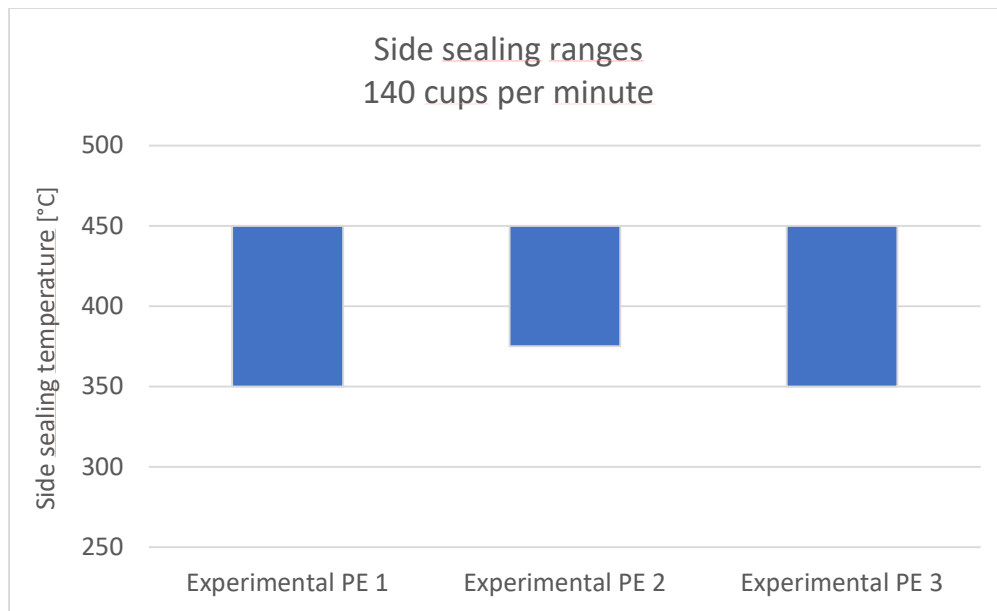
Figure 21. Side seam sealing ranges to reach full fiber tear in experimental materials 1,2 and 3

As seen in the figure, experimental materials 1 and 3 had a slightly wider sealing temperature range of 350 °C to 450 °C compared to experimental material 2, which could be explained by the material's slightly higher grammage of polymer coating (~8% difference). The achieved sealing ranges and seal quality are comparable to PE-coated boards, as can be seen in Figure 17 of the reference runs.

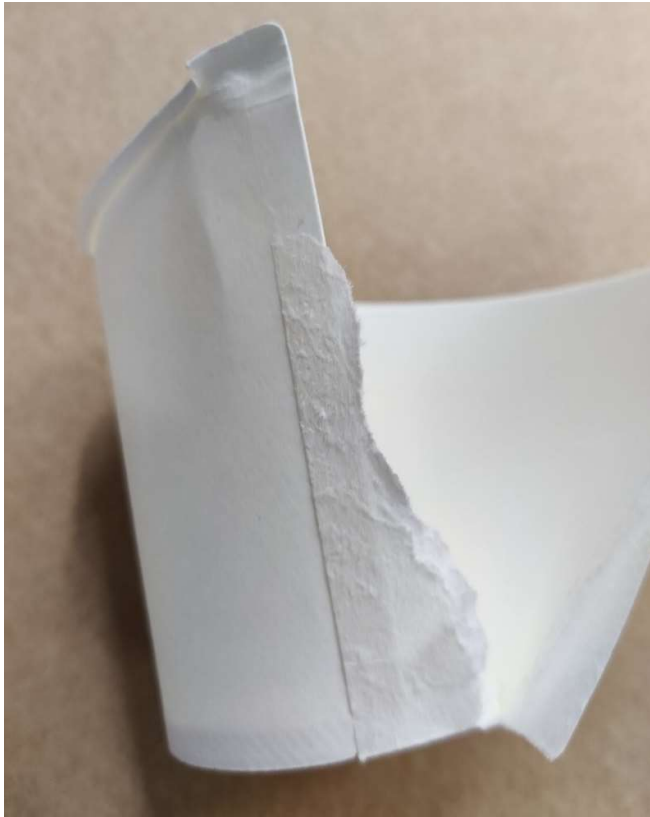
An incomplete side seam seal near the rim roll is presented in Figure 24. This defect is critical since it can compromise the cup's ability to hold liquid. This defect can usually be detected through an incomplete rim roll at the side seam as seen in Figure 25.

Figure 24. Incomplete side seam, two-side dispersion coated paperboard.

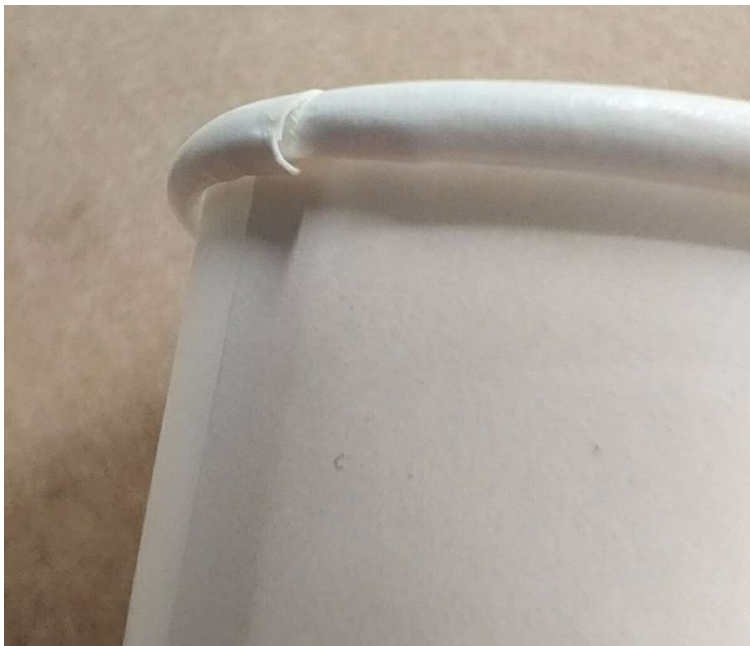
Figure 25. Opened rim roll caused by incomplete side seam. Two-side dispersion coated paperboard

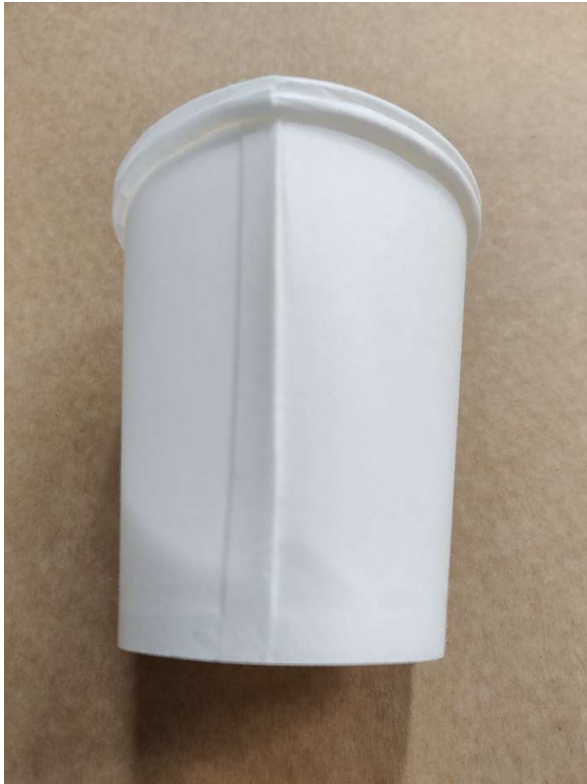
Figure 27. Folded side seam and rim roll on a defective cup

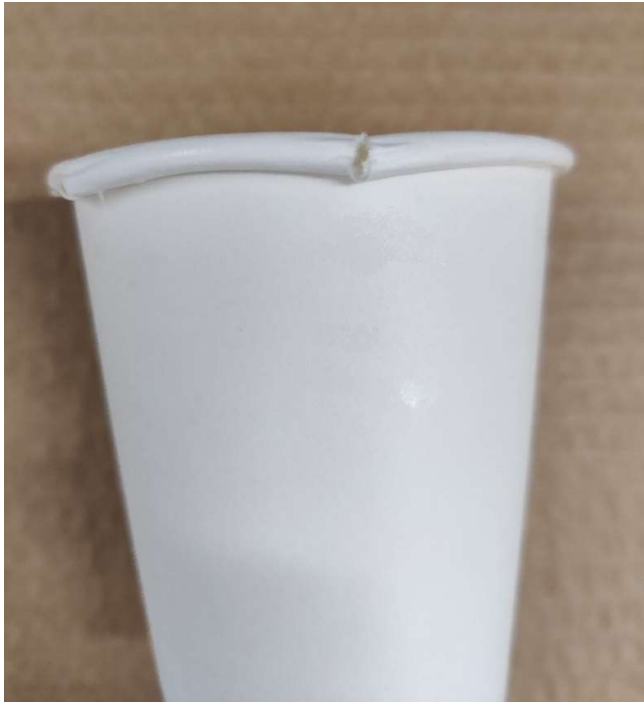
In addition to process parameters, material condition and properties also affect the defects found in the cups. Split rim rolls are a defect most often caused by low moisture content in the cupstock. Dryness causes the paperboard to act in a stiffer manner, causing the rim roll to split while being tucked, an example of which can be seen in Figure 28. Paperboards with higher bending resistance in the cross direction (CD) are more susceptible to split rims.

Figure 28. Split rim roll caused by dry cupstock. 2-side biopolymer coated paperboard

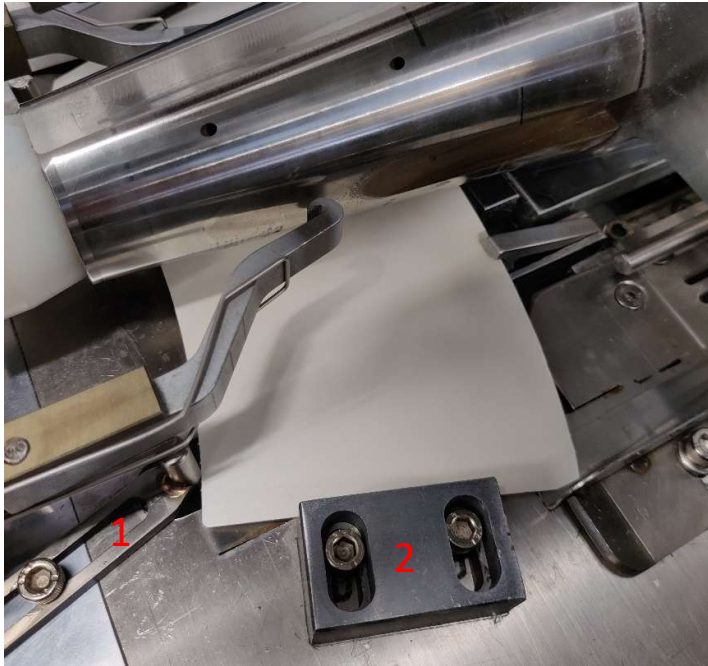
As part of this master's thesis, the tools used to stop the cup blanks in the correct position before the side seaming step were redesigned for the cup forming machine used at the LUT packaging laboratory. The purpose of the redesigned blank positioning tool was to reduce variance in adjustments by reducing the number of components in the assembly. The original system presented in Figure 29 consisted of two metal stopper pegs and two rectangular alignment parts. The pegs stop the blank in the process direction, while the aligners dictate the blank position in the cross-direction. All parts were independently adjustable, often leading to misalignment in the cross-direction resulting in multiple readjustments. Readjusting to a previously set position was also difficult.

Figure 29. Original positioning system. The stopper peg (1) and guide piece (2) have identical counterparts on the other side of the mandrel, not visible in the figure.

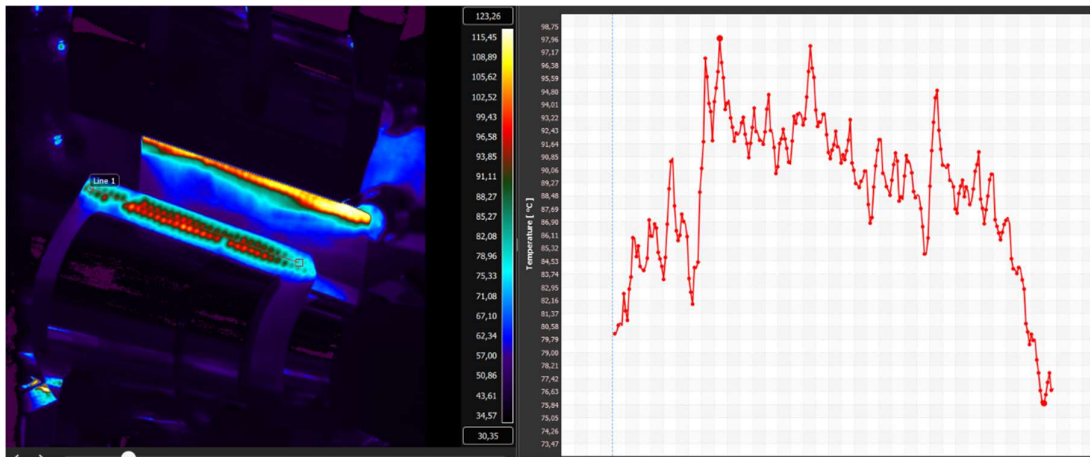
Figure 32. Side seam temperature after hot air heating pre adjustment. (Right-hand graph: highest temperature ~ 98 °C and lowest temperature ~ 76 °C)

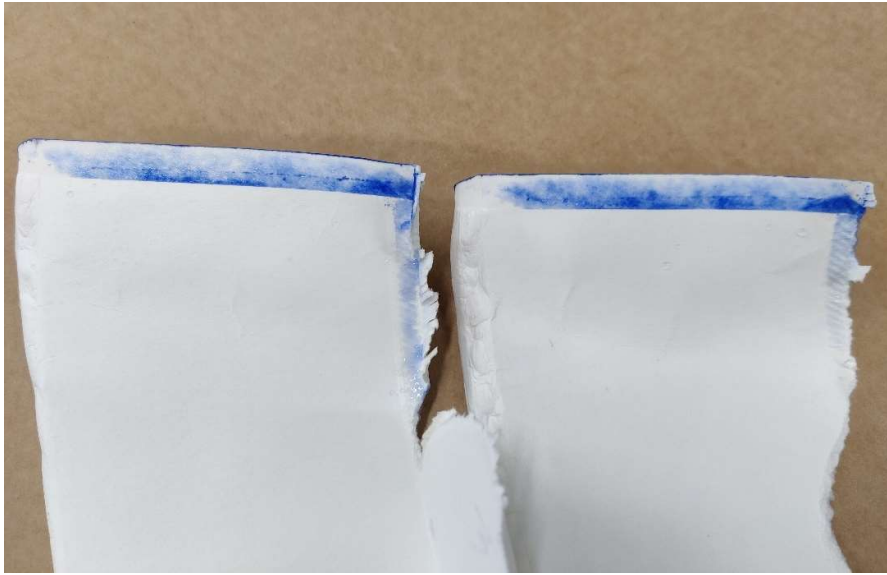
Figure 37. Torn side seams of cold run (left) and hot run (right) with added dyed soap water displaying the portion of fiber tear.

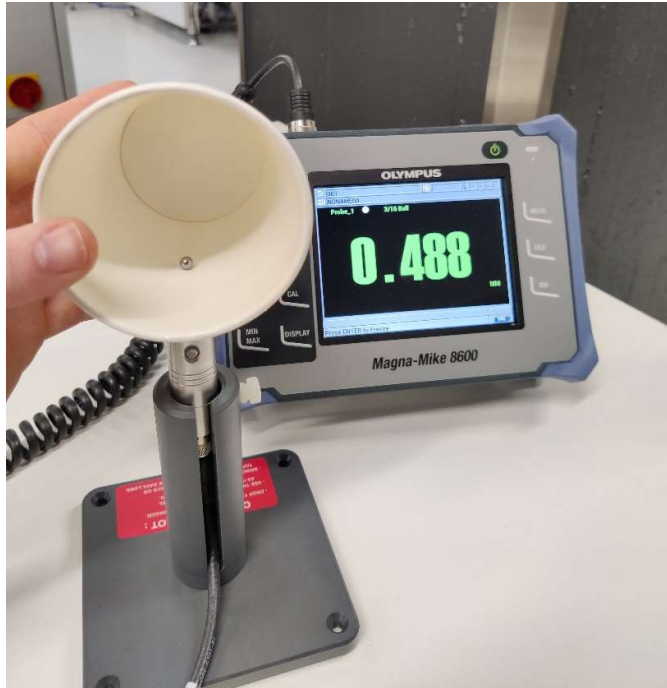
Figure 43. Measuring the thickness of the side seam at the middle point
