WINDSCALE FIRE: EXAMINING THE CONTROVERSIAL CHAPTER OF NUCLEAR HISTORY

A literature review of the Windscale accident of October 10, 1957

Bachelor's Programme in Technology and Engineering Science, Bachelor's thesis

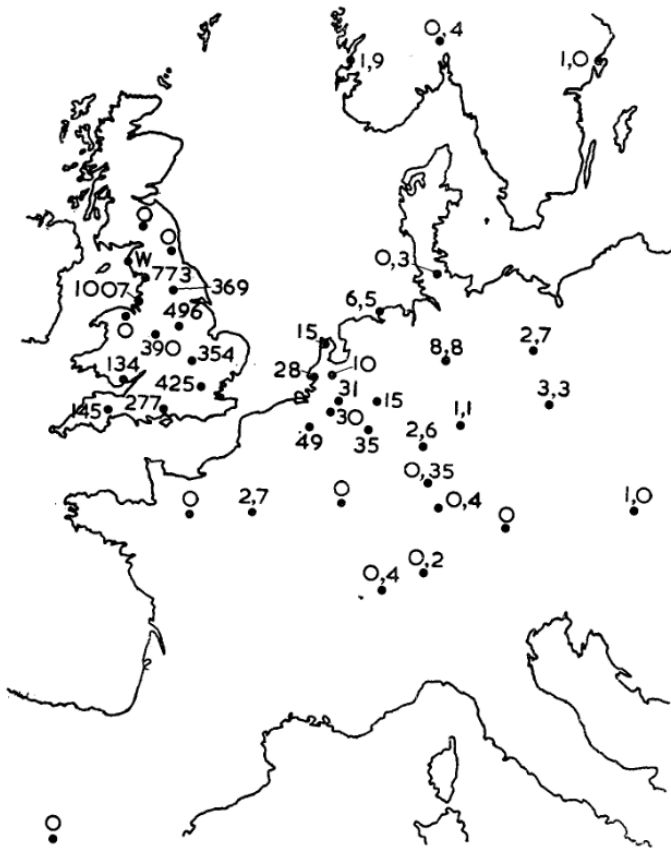
Figure 5. A map displaying the time integral of the concentration of ^{131}I in the air (micro-microcurie-days per cubic metre) in Europe following the Windscale accident in October, 1957 (Loutit et al. 1960).

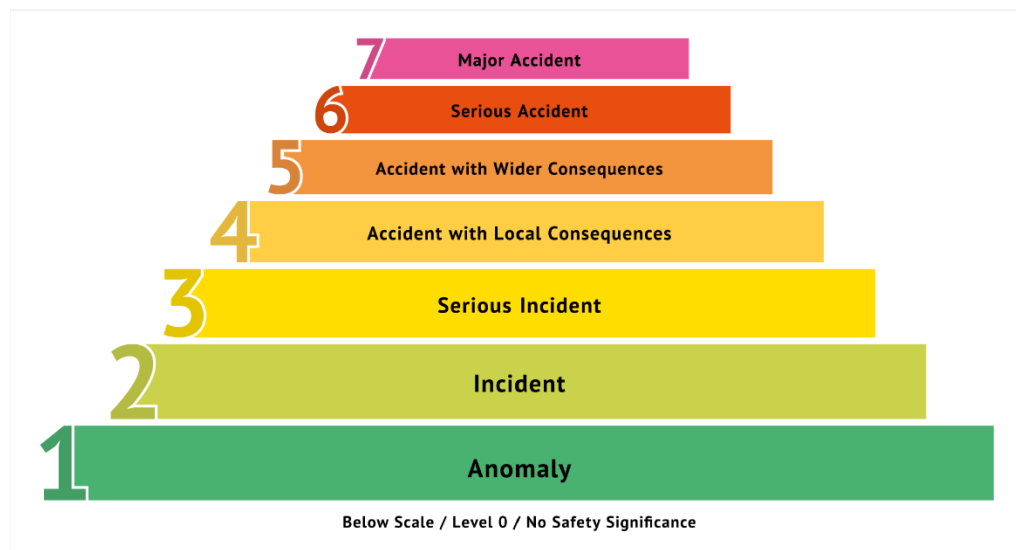
Figure 6. A representation of the INES levels as a pyramid (Simopt, s.r.o. 2021).

Despite the initial assertion that the Windscale accident had limited impact, its severity was ultimately recognized with a Level 5 classification on the INES scale (Sneddon 2010, 50.). INES was developed by the IAEA and the NEA (see Figure 6) in May 1990, to classify nuclear power plant events and later all installations linked to the civil nuclear sector (IAEA 2017). All nuclear and radiological incidents are classified by INES by considering three areas of impact:
